Glen Earrach Pumped Storage Hydro

Environmental Impact Assessment Report

Appendix 10.3: Geomorphic Baseline and Watercourse Crossings

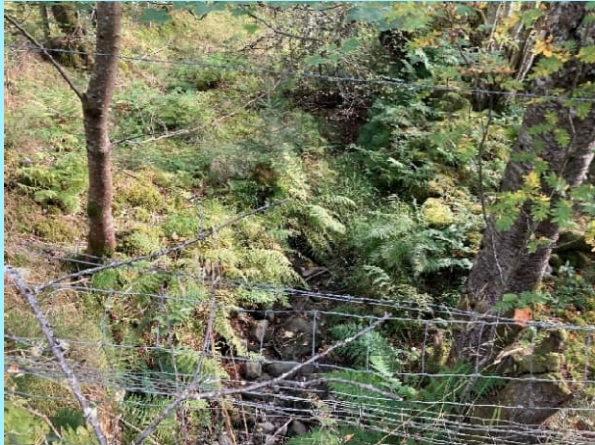
ID, NGR and Crossing Type	Description	Upstream	Downstream
SW19 Crossing 1 NH 44995 29817 Type 4 – Bailey Bridge	<p>New temporary watercourse crossing (bridge) over the River Enrick which has a High WFD status for morphology. The crossing will be a single spanning structure with abutments for use during the construction phase. Located approximately 1km downstream of the outflow of Loch Meiklie.</p> <p>Large, stable cobbles were visible along the outer edges of this fast-flowing watercourse. Trees and dense vegetation line the riverbanks.</p>

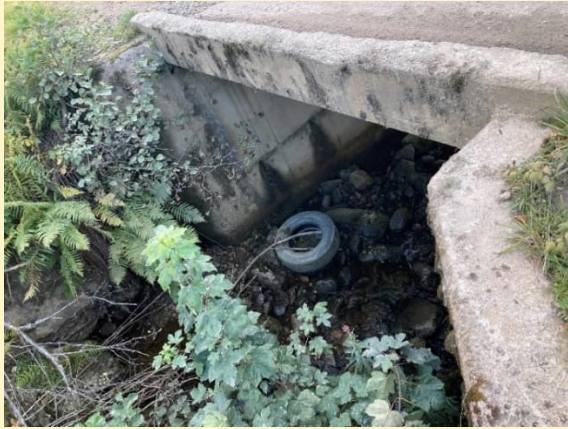
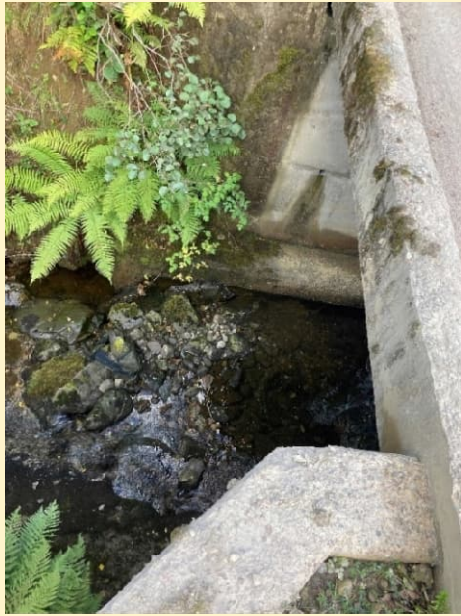
No Associated Photographs
SW20 Crossing 1 NH45183 29549 Type 3 – Bottomless Culvert	<p>Existing watercourse crossing (a concrete bottomless box culvert) at Allt Creag an Fhithich approx. 25m upstream of the confluence with the River Enrick. The crossing is located on the existing Forestry and Land Scotland (FLS) access track.</p> <p>The watercourse in this location has a stable bedrock and step pool typology. Some stable cobbles have been deposited both upstream and downstream of the structure.</p>

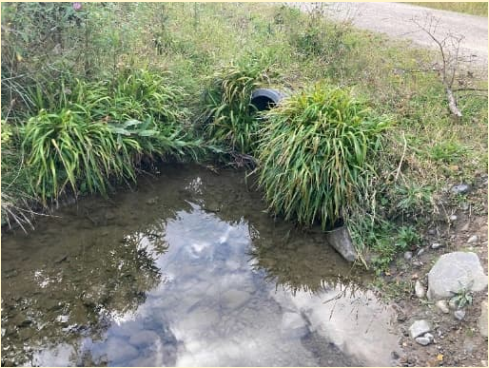
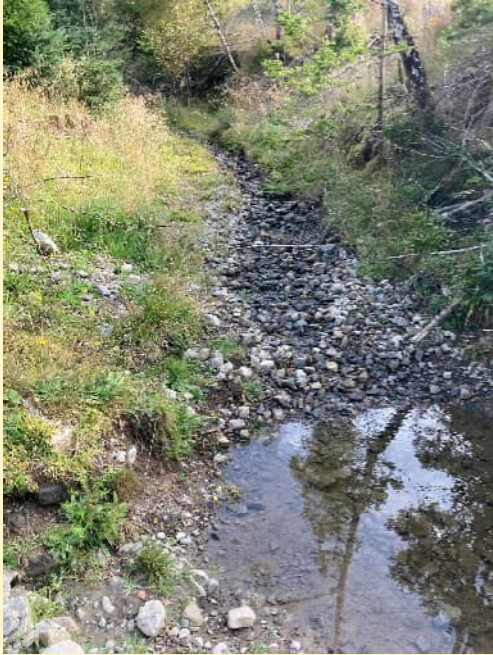
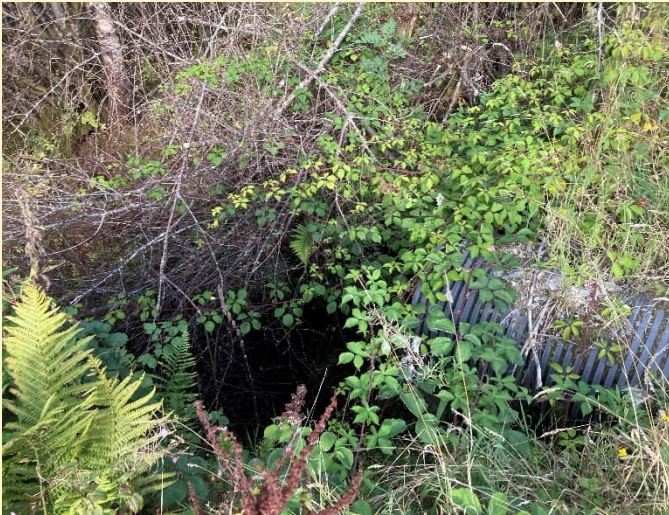
ID, NGR and Crossing Type	Description	Upstream	Downstream
SW21 Crossing 1 NH45255 29549 Type 1/Type 2 – Closed Pipe	<p>Existing watercourse crossing of Caochan na Ruighe Duibhe, a tributary to River Enrick. The crossing is a corrugated plastic pipe, located on the existing FLS access track.</p> <p>The channel upstream of the crossing is subject to extensive gravel deposition. This is likely due to the constraint created by the existing culvert inlet which is set above the bed, leading to a drop in energy and the formation of a pool.</p> <p>The channel downstream was heavily vegetated at the time of the site visit and therefore difficult to view, however the culvert outlet also appears to sit at a higher invert level than the bed which may cause a scouring effect during high flows.</p>

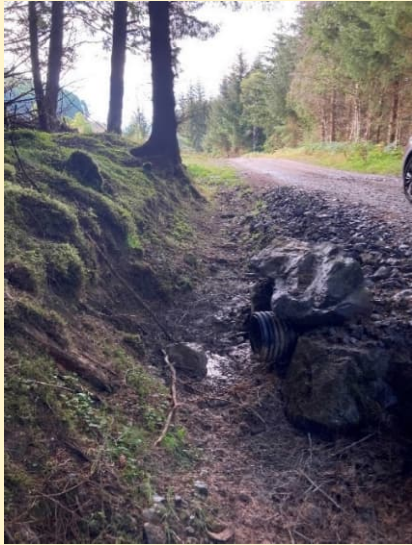
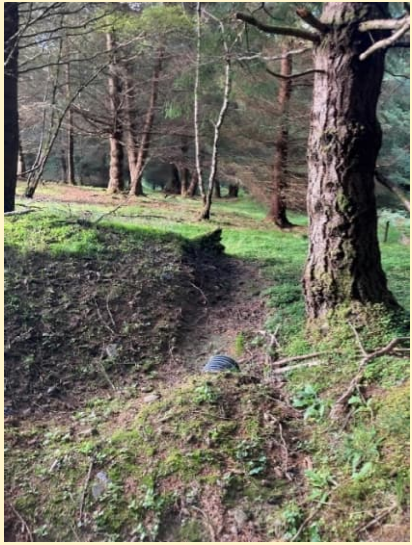
ID, NGR and Crossing Type	Description	Upstream	Downstream
SW28 Crossing 1 NH45477 29475 Type 1/Type 2 – Closed Pipe	<p>Crossing of unnamed watercourse / drainage ditch. The crossing is a corrugated plastic pipe, located on the existing FLS access track.</p> <p>The crossing is located on a ditch which had no flow during the time of survey.</p>

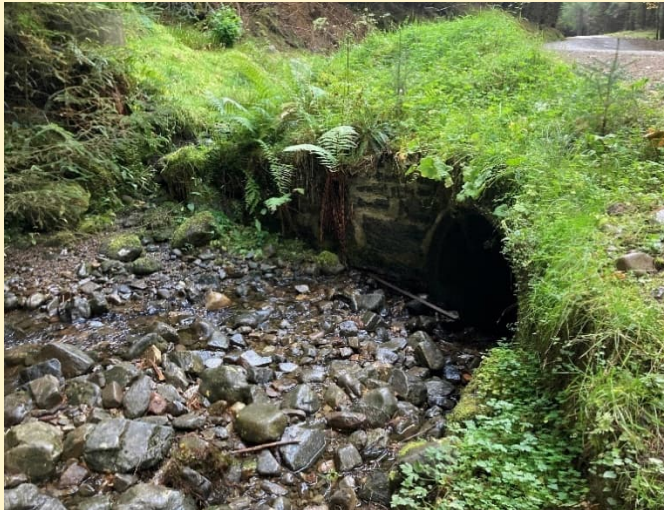
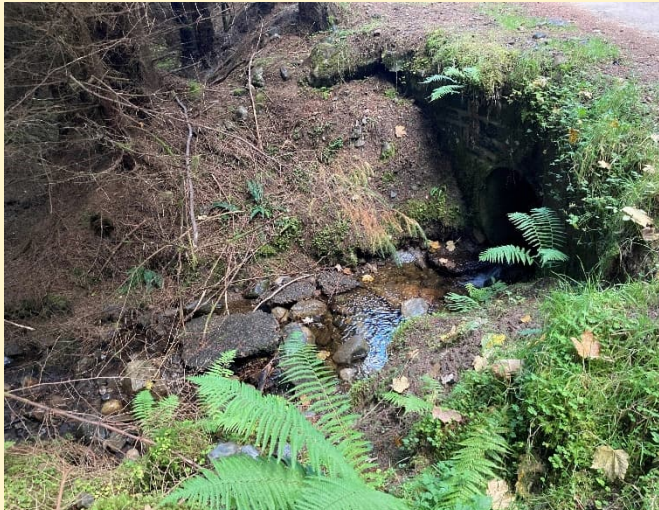
SW22 Crossing 1 NH45741 29415 Type 3 – Bottomless Culvert	<p>Existing watercourse crossing of Allt na Criche. The crossing is a single culvert with stone surround and is located on the existing FLS access track.</p> <p>The channel upstream and downstream of this structure is subject to extensive gravel and cobble deposition, likely related to the constriction created by the culvert. The channel is wide and flows steeply downhill with large stable boulders evident.</p>

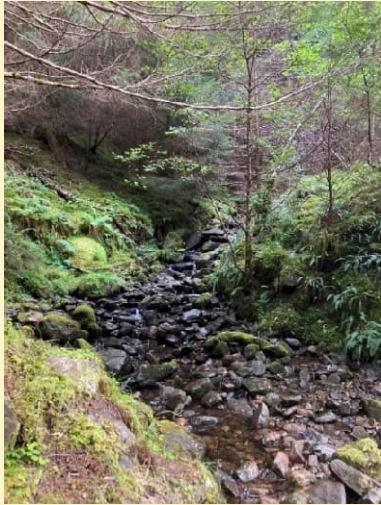
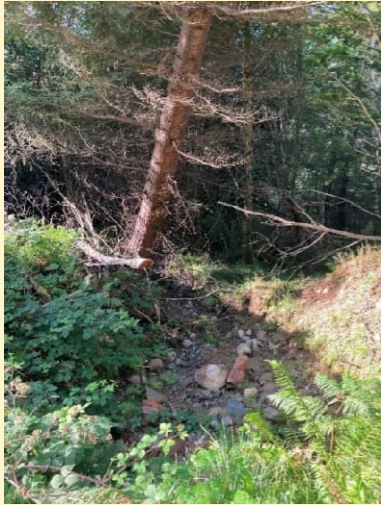
ID, NGR and Crossing Type	Description	Upstream	Downstream
SW23 Crossing 1 NH46498 29484 Type 1/Type 2 – Closed Pipe	Existing watercourse crossing of unnamed tributary to the River Enrick. The crossing is a corrugated plastic pipe, located on the existing FLS access track. Upstream, the channel is steep, flowing through commercial forestry. There is extensive gravel and cobble deposition, likely related to the constriction created by the culvert.

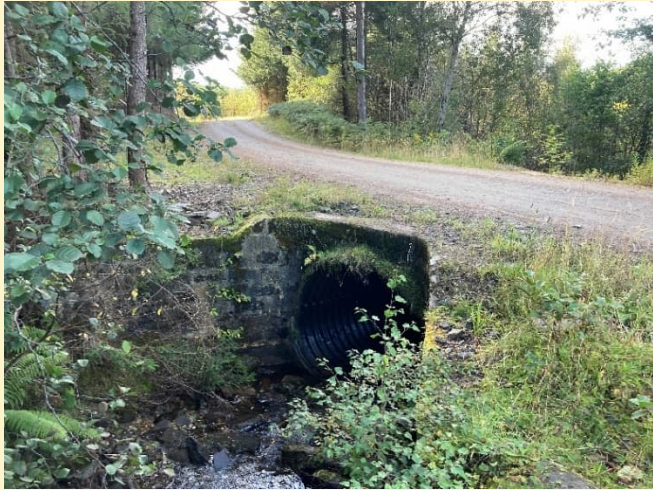
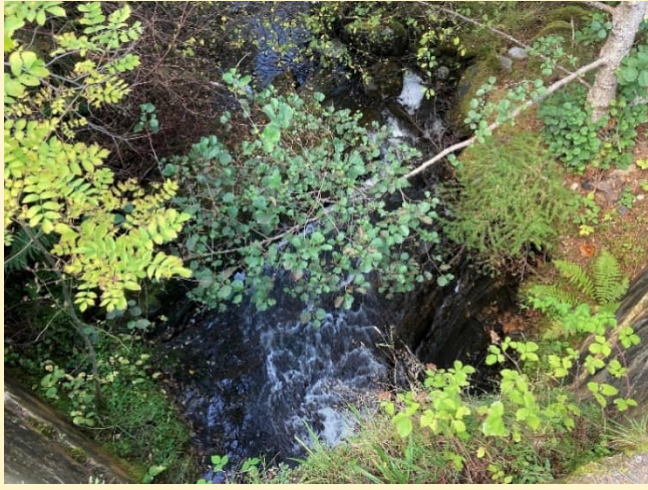
SW24 Crossing 1 NH46924 29606 Type 1/Type 2 – Closed Pipe	Existing watercourse crossing of Allt Luirg nam Broc. The crossing is a corrugated plastic pipe within a stone surround, located on the existing FLS access track. Upstream of the crossing, the channel flows over bedrock with step pool formations and small waterfall features. There are large boulders and cobbles contained within the channel. Downstream the channel bed also appears to consist of bedrock.

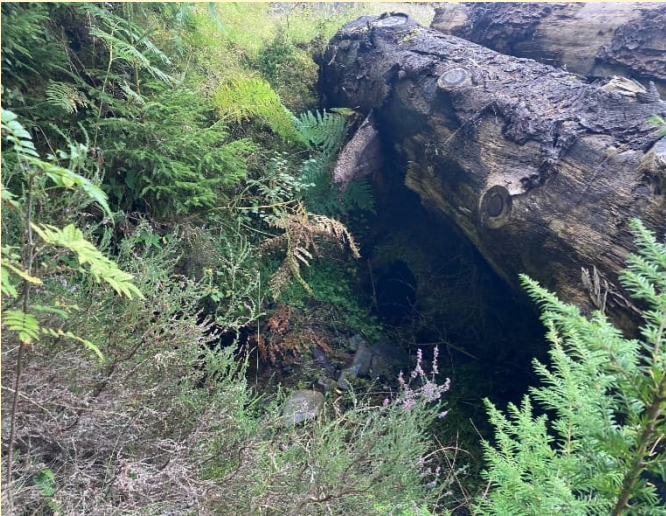
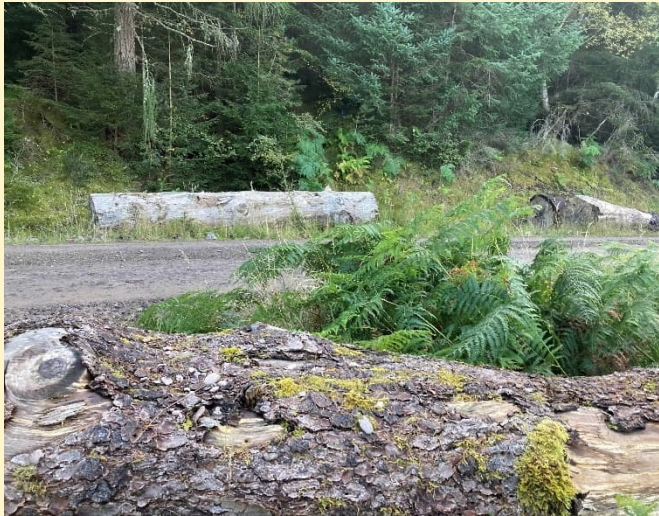
No Associated Photographs
SW26 Crossing 1 NH49374 29433 Type 1/Type 2 – Closed Pipe	Existing watercourse crossing of unnamed tributary to the River Enrick. The crossing is located on the existing FLS access track and appears to be a relatively small pipe. The watercourse flows through an area of dense forestry plantation. The channel banks were heavily vegetated at the time of the site visit and therefore the channel was difficult to view. Little flow was visible passing through the culvert. Large, felled trees have been placed at the roadside on top of the inlet and outlet structure.

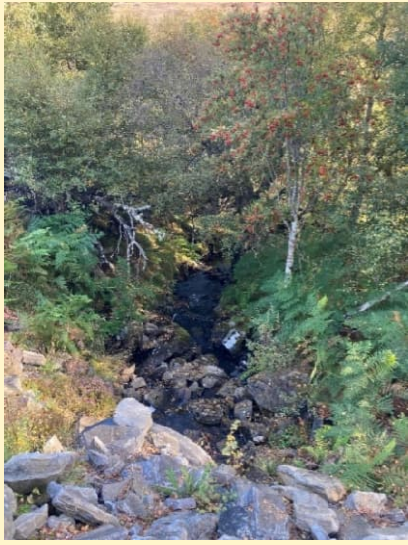
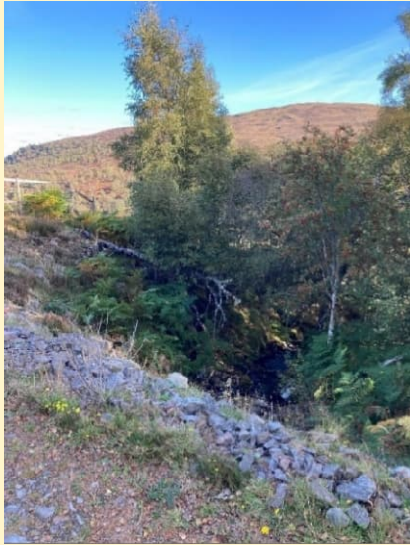
<p>No Associated Photographs</p>
<p>SW17 Crossing 1</p> <p>NH46691 27021</p> <p>Type 1/Type 2 – Closed Pipe</p>	<p>Existing watercourse crossing of Caochan an Loch Dhuibh. The crossing is a corrugated plastic pipe, located on the existing FLS access track.</p> <p>Both upstream and downstream of the culvert the channel banks are heavily vegetated with trees on the banks. Large angular material is visible in the channel around the inlet which is part of the road construction.</p>

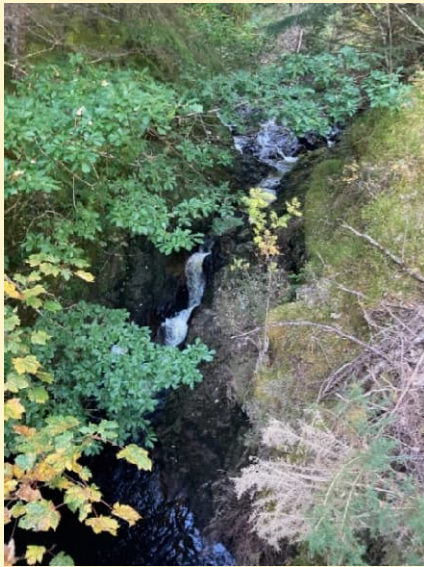
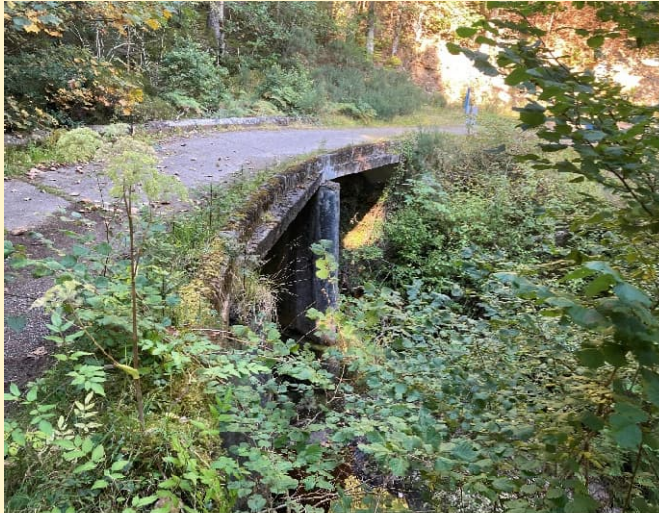
<p>SW3 Crossing 1</p> <p>NH45591 19142</p> <p>Type 3 – Bottomless Culvert</p>	<p>Existing access track watercourse crossing of Allt Saigh. The crossing is a bridge with piers.</p> <p>The Allt Saigh is a steep bedrock channel and the crossing is located close to the confluence with Loch Ness. Upstream of the crossing, the watercourse comprises of a short cascade reach within a steep bedrock channel and a small pool has formed immediately upstream of the crossing.</p> <p>Downstream of the crossing, the bed is made up of protruding large bedrock outcrops.</p>

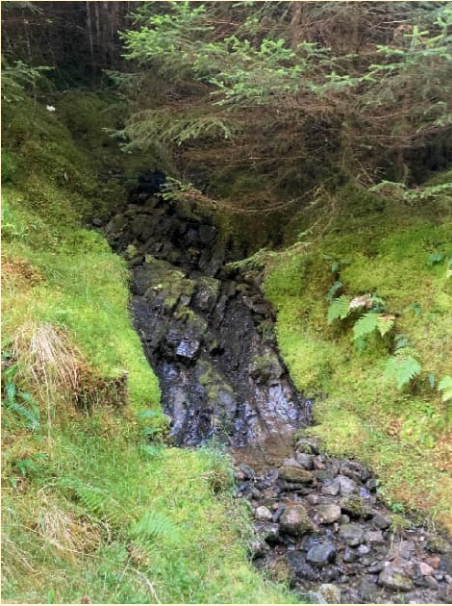
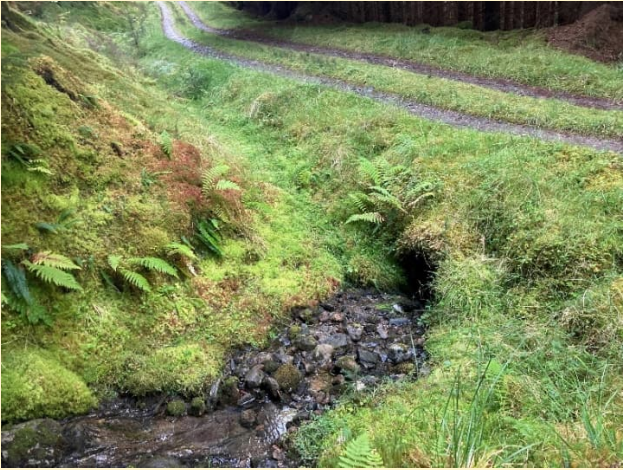
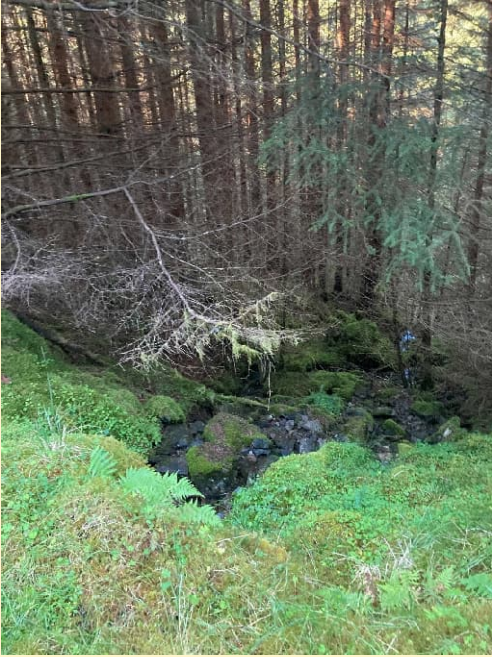
ID, NGR and Crossing Type	Description	Upstream	Downstream
SW3-D Crossing 1 NH44313 19287 Type 1/Type 2 – Closed Pipe	<p>Existing access track crossing of un-named watercourse which is a tributary of the Allt Saigh.</p> <p>The watercourse has a very steep gradient with bedrock visible upstream Some cobbles and gravels are visible in the channel upstream of the crossing.</p>

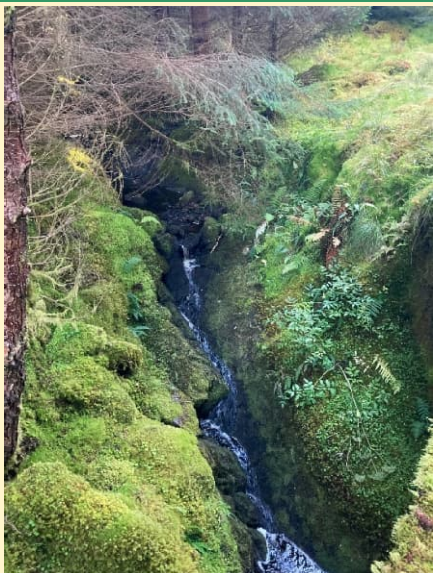
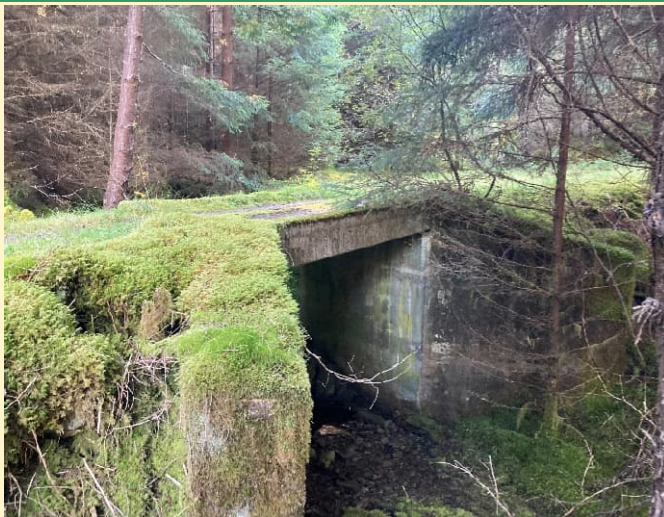
ID, NGR and Crossing Type	Description	Upstream	Downstream
SW3-F Crossing 1 NH44047 19197 Type 3 – Bottomless Culvert	<p>Existing access track watercourse crossing of unnamed watercourse which is a tributary of the Allt Saigh. The crossing is a bottomless concrete box culvert with wingwalls and a natural channel bed.</p> <p>Upstream, the channel is very steep, in an incised bedrock reach, with a supply of cobble and gravel material. At the upstream face of the current crossing, the gradient is lower and a pool has formed. Potentially transportable cobble and large gravels are present in the channel downstream of the crossing.</p>

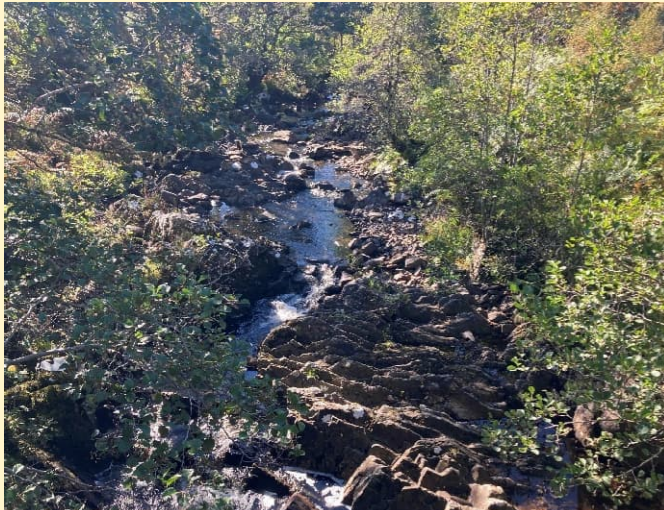
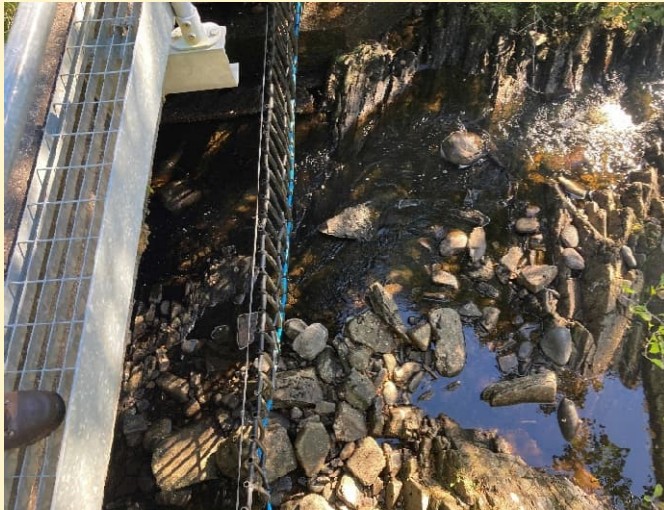
SW3 Crossing 2 NH43731 19254 Type 4 – Bailey Bridge	<p>Existing access track watercourse crossing of the Allt Saigh. The current structure is an open span metal bridge which has a suspended trash screen structure.</p> <p>Upstream of the bridge, the river is characterised by a bedrock and boulder channel with cobbles and gravels which may be transportable. The river flows through a confined valley, with trees along much of the riparian corridor in this reach.</p>

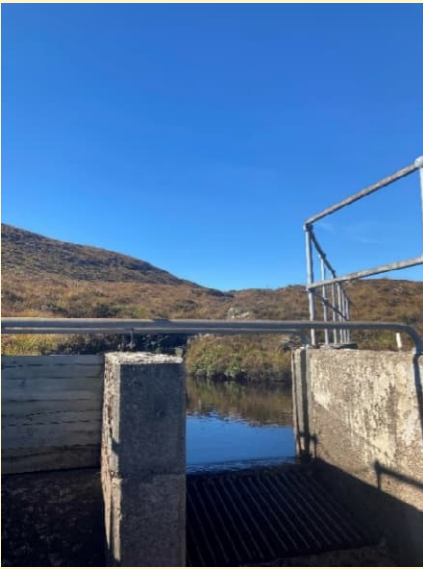
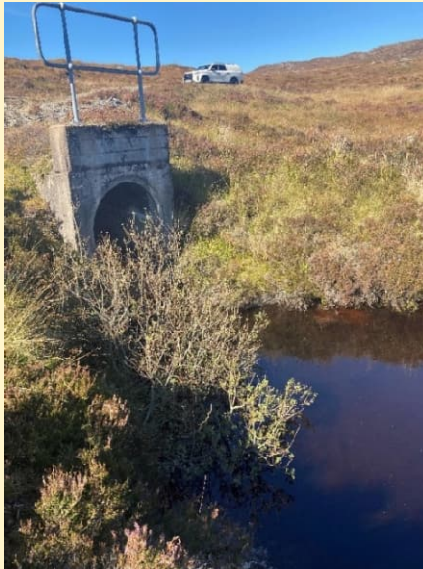
ID, NGR and Crossing Type	Description	Upstream	Downstream
SW7 Crossing 1 NH434172132 1 Type 1/Type 2 – Closed Pipe	<p>Existing access track watercourse crossing/impoundment of unnamed tributary to Allt Loch an t-Sionnaich. The crossing is located at an intake structure where the watercourse is dammed.</p> <p>Sediment transport processes are likely to be significantly impacted by the intake structure. Downstream of the crossing, water emerges through a circular concrete culvert into a relatively low gradient channel with significantly reduced flows.</p>
