Glen Earrach Pumped Storage Hydro

Environmental Impact Assessment Report

Volume 5: Appendices
Appendix 7.6: Outline Peatland Restoration Plan

Glen Earrach Energy Ltd

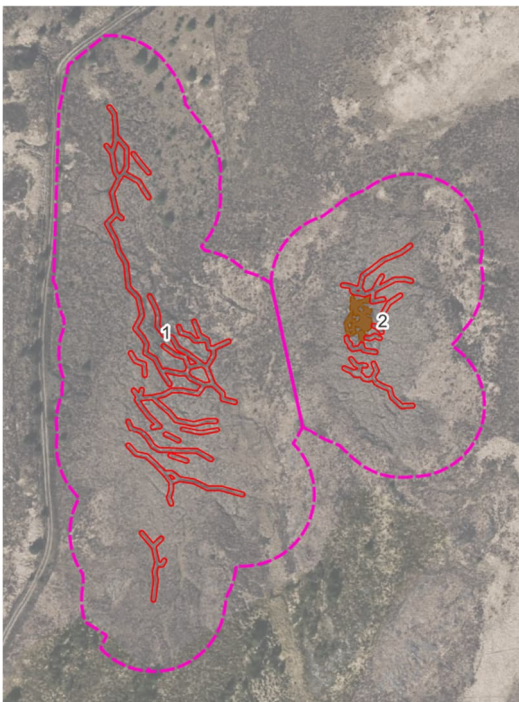
Restoration Area ID and Description	Recommended Restoration Techniques	Image
<p>Area ID: 1</p> <p>Grid reference: NH 43529 20411</p> <p>Areas: Restoration Area – 21,189 m² Gullies – 1,275 m²</p> <p>Peat depth: Area largely beyond peat probing, though very north gully within an area of 0.5-0.99 m depth.</p> <p>Description: Gullies largely located within M17b/M19a/ M2/M1 (80/10/1/1) communities, with small amount located within M15c to very south. No significant areas of flat bare peat.</p>	<p>Restoration of eroded/bare areas using machine-based techniques.</p> <p>Access via existing track present to west of area (which will join to new permanent track to north).</p>

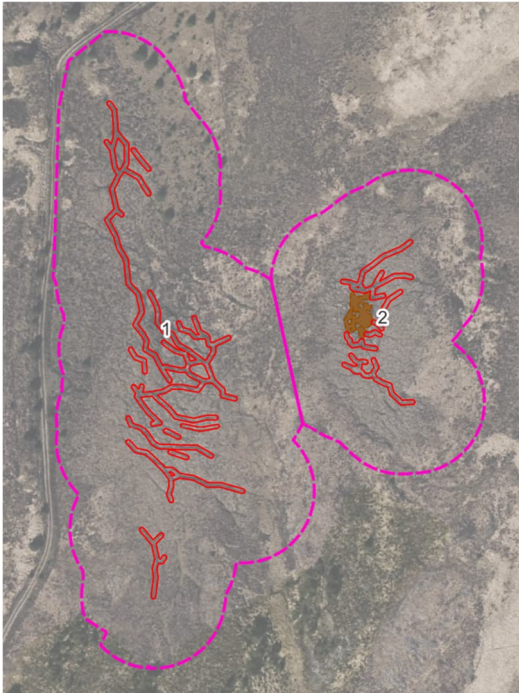
<p>Area ID: 2</p> <p>Grid reference: NH 43623 20417</p> <p>Areas: Restoration Area – 9,413 m² Bare peat – 137 m² Gullies – 378 m²</p> <p>Peat depth: Area beyond peat probing.</p> <p>Description: Gullies largely located within M17b/M19a/ M2/M1 (80/10/1/1) communities, with small amount located within M17b/Peat (70/30). A relatively large area of flat bare peat is present, presumed due to deer erosion prior to exclusion by existing deer fencing, and not yet recovered.</p>	<p>Restoration of eroded/bare areas using machine-based techniques.</p> <p>Access via existing track present to west of area (which will join to new permanent track to north), and bypassing Area 1 using surrounding wet heath habitat.</p>

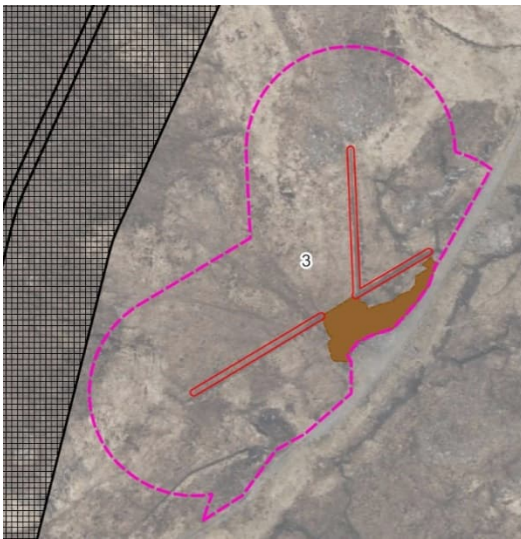
Restoration Area ID and Description	Recommended Restoration Techniques	Image
<p>Area ID: 3</p> <p>Grid reference: NH 43616 21615</p> <p>Areas: Restoration Area – 8,466 m² Bare peat – 324 m² Gullies – 232 m²</p> <p>Peat depth: Area largely within peat depth of 0.5-0.99 m, with some areas of >1 m depth.</p> <p>Description: Gullies located within M15a/M15b/M17a (34/33/33), M17a (100), and M15b/M17a/M15a (45/45/10), with one significant area of flat bare peat present adjacent to existing access track. Surrounds also include M15c/M15b/ M17b/H10b (45/45/9.9/0.1)</p>	<p>Restoration of eroded/bare areas using machine-based techniques.</p> <p>Access via existing track present adjacent to area (which will join to new permanent track to north).</p>

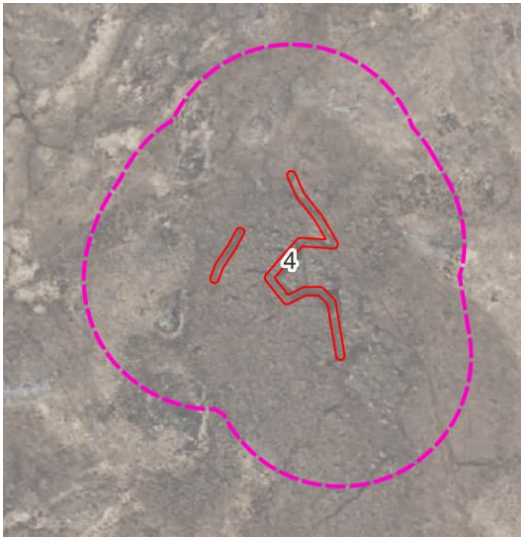
<p>Area ID: 4</p> <p>Grid reference: NH 43360 22006</p> <p>Areas: Restoration Area – 7,072 m² Gullies – 171 m²</p> <p>Peat depth: Part of Restoration Area is within an area of >1 m depth, with most of 0.5-0.99 m depth.</p> <p>Description: Gullies largely located within M17/M2 (90/10), with pronounced hummock-hollow-like haggling but vegetated, and with M17a (100) and M15c/M15b/M15c/M19a/ M17b/Rock (94.6/5/0.1/0.1/0.1/0.1) in the surrounds. No significant areas of flat bare peat.</p>	<p>Restoration of eroded/bare areas using machine-based techniques.</p> <p>Access via new permanent track which will be constructed approximately 260 m east of area, and across intervening wet heath habitat.</p>

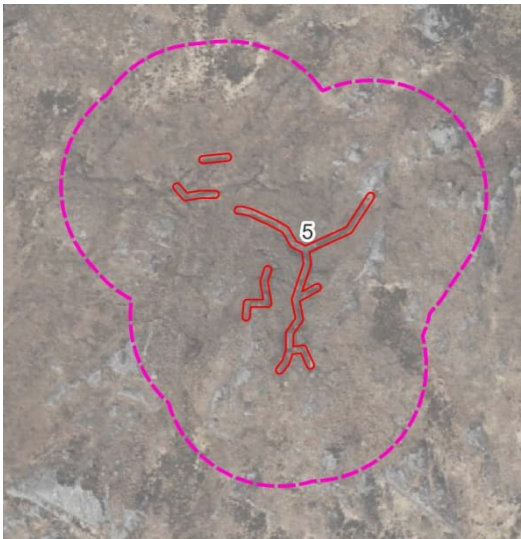
<p>Area ID: 5</p> <p>Grid reference: NH 43622 22373</p> <p>Areas: Restoration Area – 9,632 m² Gullies – 272 m²</p> <p>Peat depth: Most of Restoration Area is within an area of 0.5-0.99 m depth, with some in an area of 0.3-0.49 m and the remainder <0.3 m.</p> <p>Description: Gullies located within M17b (100). No significant areas of flat bare peat present. M15c/M15b/M17b/M19c (78/20/1/1) and M15c/M15b/M15c*/M19a/M17b/Rock (94.6/5/0.1/0.1/0.1/0.1) comprises the remainder of the area.</p>	<p>Restoration of eroded/bare areas using machine-based techniques.</p> <p>Access via new permanent track which will be constructed approximately 340 m north of area, and across intervening wet heath habitat.</p>

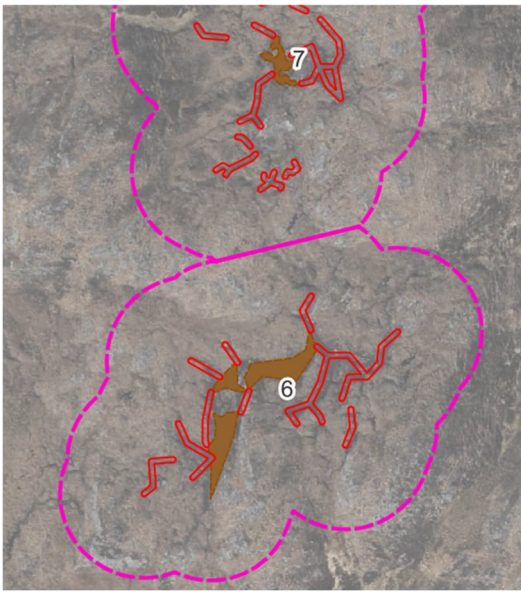
Restoration Area ID and Description	Recommended Restoration Techniques	Image
<p>Area ID: 6</p> <p>Grid reference: NH 44042 22610</p> <p>Areas: Restoration Area – 14,306 m² Bare peat – 399 m² Gullies – 434 m²</p> <p>Peat depth: Most of Restoration Area is within an area of 0.3-0.49 m and 0.5-0.99 m depth, with a small amount of <0.3 m.</p> <p>Description: Gullies located within M19c/M17b/Peat (50/30/20) with three significant areas of flat bare peat. The surrounding comprises M15c/M19c/ M15a (80/19/1), M15c/H14 (99.9/0.1), and M15c/M15b/M15a/M17b (80/13/1.9/0.1)</p>	<p>Restoration of eroded/bare areas using machine-based techniques.</p> <p>Access via new permanent track which will be constructed approximately 270 m west of area, and across intervening wet heath habitat.</p>

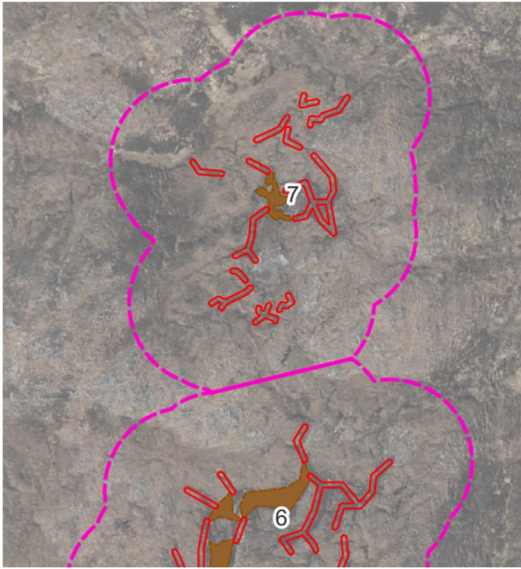
<p>Area ID: 7</p> <p>Grid reference: NH 44046 22731</p> <p>Areas: Restoration Area – 12,873 m² Bare peat – 84 m² Gullies – 494 m²</p> <p>Peat depth: Most of Restoration Area is within an area of >1 m peat depth, with the surrounding areas 0.5-0.99 m depth.</p> <p>Description: Gullies located within M17a/M19a/M17b/M15c*/Peat/Rock/M1 (30/30/20/14/3/2/1), with one significant area of flat bare peat. The surrounding comprises M15c/ M19c/M15a (80/19/1) and H12b/M15c/ M15b/M15a/M10 (60/15/15/9.5/0.5)</p>	<p>Restoration of eroded/bare areas using machine-based techniques.</p> <p>Access via new permanent track which will be constructed approximately 320 m west of area, and across intervening wet heath habitat.</p>

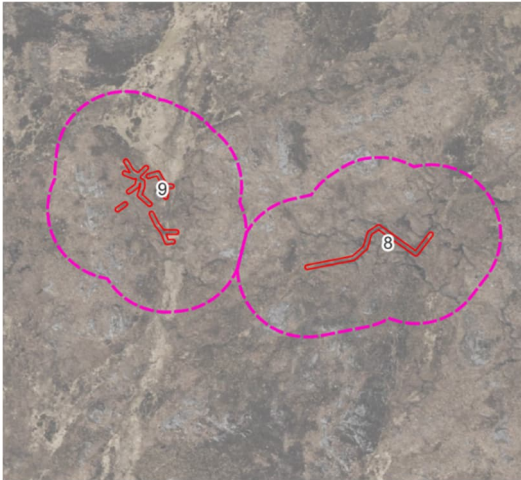
<p>Area ID: 8</p> <p>Grid reference: NH 43838 22687</p> <p>Areas: Restoration Area – 7,021 m² Gullies – 144 m²</p> <p>Peat depth: Most of Restoration Area is within an area of <0.3 m peat depth.</p> <p>Description: Gullies located within M17b/M1/M3 (96/2/2). There are no significant areas of flat peat. The surrounding comprises M15c/M15b/M15a/ M17b (80/13/1.9/0.1) and M15c/M19c/M15a (80/19/1).</p>	<p>Restoration of eroded/bare areas using machine-based techniques.</p> <p>Access via new permanent track which will be constructed approximately 500 m west of area, and across intervening wet heath habitat.</p>

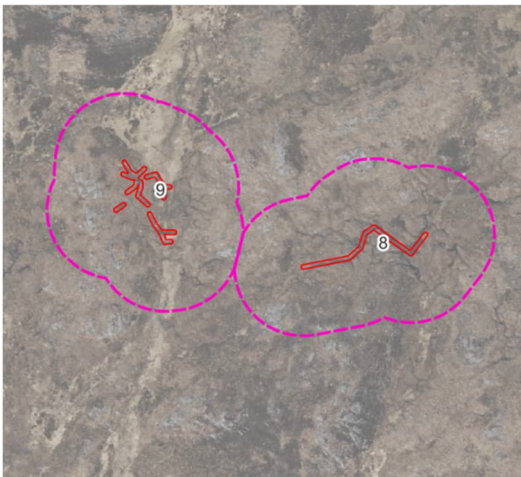
Restoration Area ID and Description	Recommended Restoration Techniques	Image
<p>Area ID: 9</p> <p>Grid reference: NH 43737 22711</p> <p>Areas: Restoration Area – 6,647 m² Gullies – 188 m²</p> <p>Peat depth: Most of Restoration Area is within an area of 0.5-0.99 m peat depth, with the remaining 0.3-0.49 m.</p> <p>Description: Gullies located within M17b (100). There are no significant areas of flat peat. The surrounding comprises M15c/M15b/M15c*/M19a/M17b/ Rock (94.6/5/0.1/0.1/0.1/0.1), M15c/M15b/ M15a/ M17b (80/13/1.9/0.1), M15a/M15c/ M19c/M10 (60/28/10/2), and U5c/M15a/ M15b/M10 (40/40/19/1).</p>	<p>Restoration of eroded/bare areas using machine-based techniques.</p> <p>Access via new permanent track which will be constructed approximately 600 m west of area, and across intervening wet heath habitat.</p>

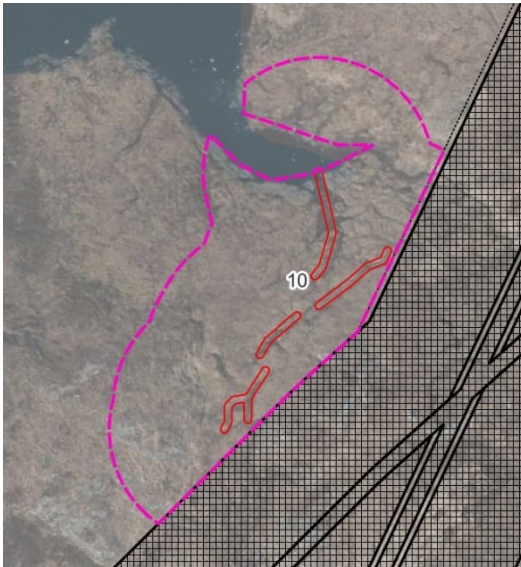
<p>Area ID: 10</p> <p>Grid reference: NH 44429 22694</p> <p>Areas: Restoration Area – 5,375 m² Gullies – 204 m²</p> <p>Peat depth: Around half of Restoration Area is within an area of 0.5-0.99 m peat depth, with most the remaining 0.3-0.49 m and <0.3 m.</p> <p>Description: Gullies located within M19c/M17b/H21/H12b (45/40/10/5). One gully flows into a lochan. There are no significant areas of flat peat in the area. The surrounding comprises M15c/H16/ H10d/M17b (99.7/0.1/0.1/0.1) and M19c/M15c (50/50).</p>	<p>Restoration of eroded/bare areas using machine-based techniques.</p> <p>Access via new permanent track which will be constructed immediately east of area.</p>

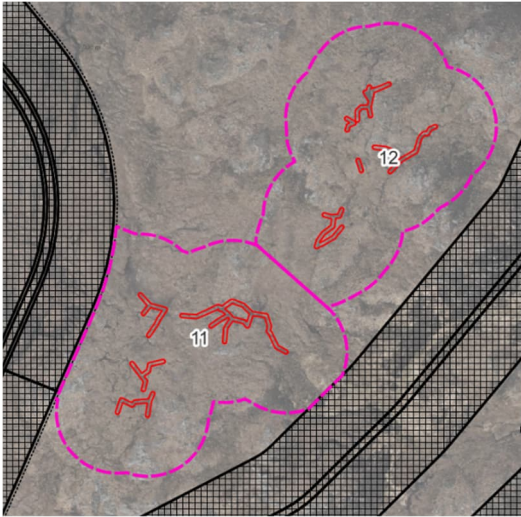
<p>Area ID: 11</p> <p>Grid reference: NH 44655 22852</p> <p>Areas: Restoration Area – 12,181 m² Gullies – 488 m²</p> <p>Peat depth: Most of Restoration Area is within an area of 0.5-0.99 m depth, with a small amount of >1 m and 0.3-0.49 m.</p> <p>Description: Gullies located within M17b/M19a/M15c (50/40/5). There are no significant areas of flat peat in the area. The surrounding includes M15c/M19c/M17b (70/20/10) and M15c (100).</p>	<p>Restoration of eroded/bare areas using machine-based techniques.</p> <p>Access via new permanent track which will be constructed immediately south east of area.</p>

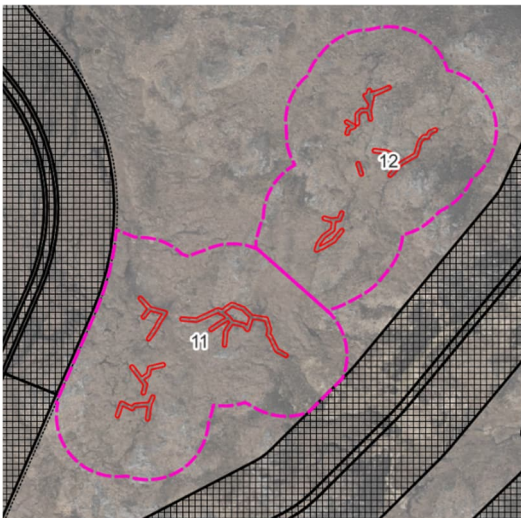
Restoration Area ID and Description	Recommended Restoration Techniques	Image
<p>Area ID: 12</p> <p>Grid reference: NH 44751 22943</p> <p>Areas: Restoration Area – 11,113 m² Gullies – 315 m²</p> <p>Peat depth: Most of Restoration Area is within an area of 0.5-0.99 m depth, with a small amount of 0.3-0.49 m.</p> <p>Description: Gullies located within M17b/M15c/H14/M2 (75/24.8/0.1/0.1), with bog pools. There are no significant areas of flat bare peat in the area. The surrounding area comprises M15c/M19c/M17b (70/20/10).</p>	<p>Restoration of eroded/bare areas using machine-based techniques.</p> <p>Access via new permanent track which will be constructed immediately south east of area.</p>

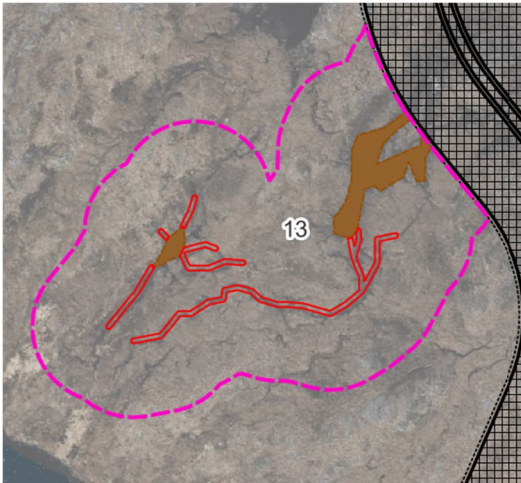
<p>Area ID: 13</p> <p>Grid reference: NH 44454 22954</p> <p>Areas: Restoration Area – 17,180 m² Bare peat – 781 m² Gullies – 527 m²</p> <p>Peat depth: Majority of Restoration Area is within an area of 0.5-0.99 m peat depth, with a small amount of >1 m.</p> <p>Description: Majority of area located within M17b/M19c/Peat (60/37/3). Two significant areas of flat bare peat.</p>	<p>Restoration of eroded/bare areas using machine-based techniques.</p> <p>Access via new permanent track which will be constructed immediately east of area.</p>

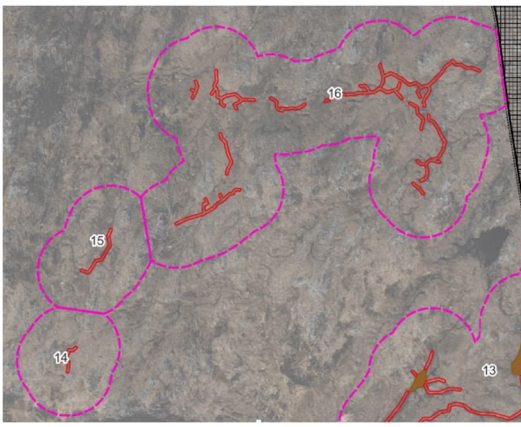
<p>Area ID: 14</p> <p>Grid reference: NH 44152 22963</p> <p>Areas: Restoration Area – 4,276 m² Gullies – 55 m²</p> <p>Peat depth: Restoration Area is within an area of <0.3 m peat depth.</p> <p>Description: Area of M15c/Rock/M19c/H16/H17 (85/10/4.9/0.1/0.1). No significant areas of flat bare peat.</p>	<p>Restoration of eroded/bare areas using machine-based techniques.</p> <p>Access via new permanent track which will be constructed immediately east of Area 16 and connected to this area.</p>

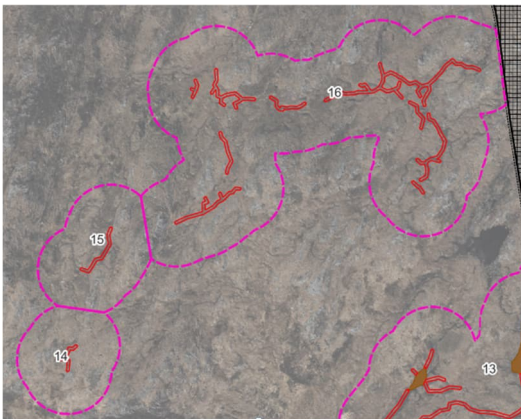
Restoration Area ID and Description	Recommended Restoration Techniques	Image
<p>Area ID: 15</p> <p>Grid reference: NH 44177 23046</p> <p>Areas: Restoration Area – 5,235 m² Gullies – 87 m²</p> <p>Peat depth: Restoration Area is within an area of <0.3 m peat depth.</p> <p>Description: Gullies located within M15c/Rock/M19c/H16/H17 (85/10/4.9/0.1/0.1), and M15c/M19a/Rock/ M17a/H16 in differing proportions. No significant areas of flat bare peat.</p>	<p>Restoration of eroded/bare areas using machine-based techniques.</p> <p>Access via new permanent track which will be constructed immediately east of Area 16 and connected to this area.</p>

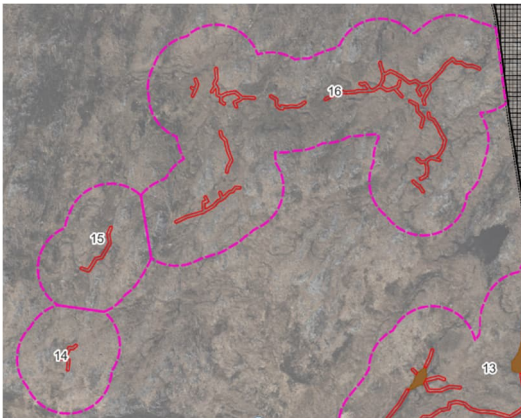
<p>Area ID: 16</p> <p>Grid reference: NH 44345 23150</p> <p>Areas: Restoration Area – 29,258 m² Gullies – 1,066 m²</p> <p>Peat depth: More than half of Restoration Area is <0.3 m peat depth, with the remaining depth of 0.3-0.49 m and some 0.5-0.99 m depth.</p> <p>Description: Gullies located within M15c/Rock/M19c/H16/H17 (85/10/4.9/0.1/0.1), and M15c/M19a/Rock/ M17a/H16/H21 in differing proportions. No significant areas of flat bare peat.</p>	<p>Restoration of eroded/bare areas using machine-based techniques.</p> <p>Access via new permanent track which will be constructed immediately east of area.</p>

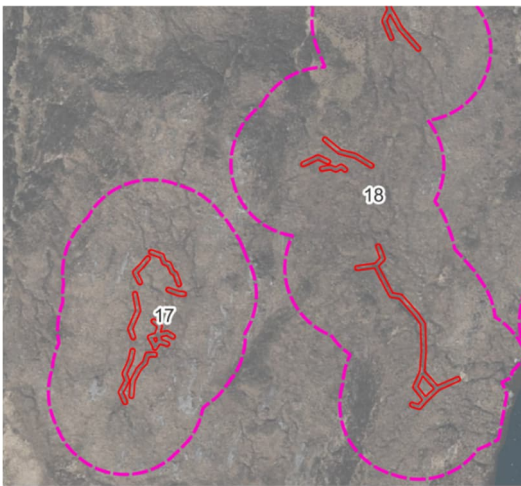
<p>Area ID: 17</p> <p>Grid reference: NH 44671 23459</p> <p>Areas: Restoration Area – 8,367 m² Gullies – 293 m²</p> <p>Peat depth: Majority of Restoration Area is within an area of >1 m peat depth, with remaining 0.5-0.99 m.</p> <p>Description: Area located within M15c/M19a/M17a/H16/Rock (92/5/1/1/1). No significant areas of flat bare peat.</p>	<p>Restoration of eroded/bare areas using machine-based techniques.</p> <p>Access via new permanent track which will be constructed approximately 210 m north and west of area, and across intervening wet heath and modified bog habitat.</p>

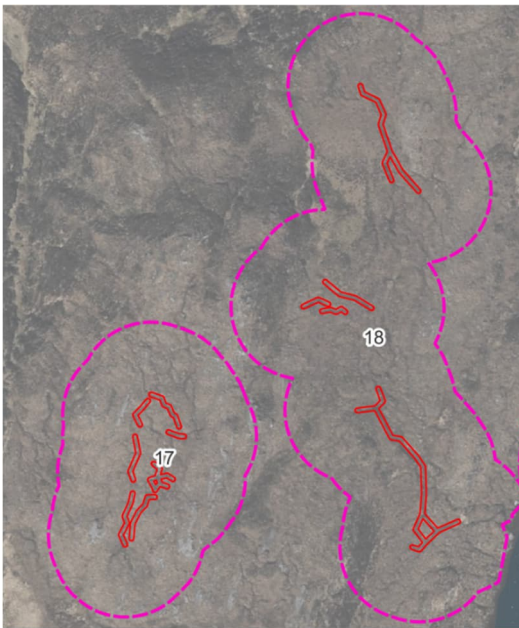
Restoration Area ID and Description	Recommended Restoration Techniques	Image
<p>Area ID: 18</p> <p>Grid reference: NH 44761 23510</p> <p>Areas: Restoration Area – 18,850 m² Gullies – 239 m²</p> <p>Peat depth: Majority of Restoration Area is within an area of 0.5-0.99 m peat depth, with remaining >1 m.</p> <p>Description: Gullies located within M15c/M17b/M19a/H16 (65/25/9.99/0.01), with M15c/M19a/M17a/ H16/Rock (92/5/1/1/1) surrounding. No significant areas of flat bare peat.</p>	<p>Restoration of eroded/bare areas using machine-based techniques.</p> <p>Access via new permanent track which will be constructed approximately 170 m north and west of area, and across intervening modified bog habitat.</p>

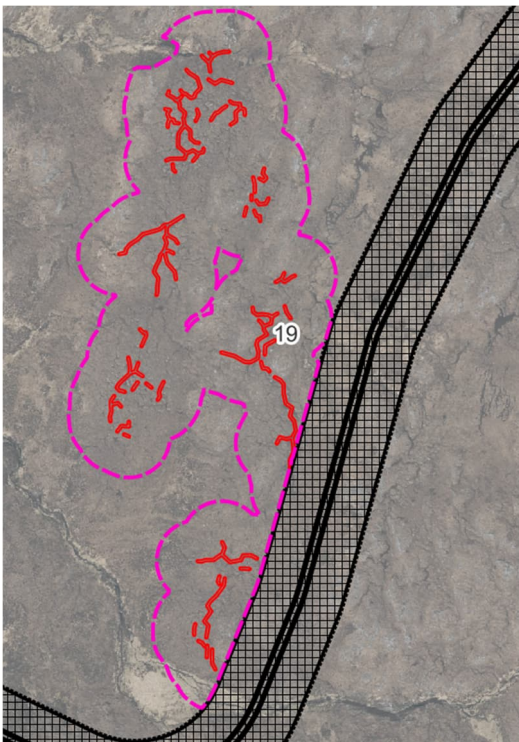
<p>Area ID: 19</p> <p>Grid reference: NH 44642 24010</p> <p>Areas: Restoration Area – 57,533 m² Gullies – 2,287 m²</p> <p>Peat depth: Area partially beyond peat probing, however approximately half of area has peat depth of 0.5-0.99 m.</p> <p>Description: Area is very expansive, and gullies are within M17b/M17a/M15c/M2/M29 (75/19.8/5/0.1/0.1) and M15c/M17b/M19a (50/30/20), with some M17b (100) and M15b/M15c/M17/M19a (40/20/20/20) around the edges of the area. No significant areas of flat bare peat.</p>	<p>Restoration of eroded/bare areas using machine-based techniques.</p> <p>Access via new permanent track which will be constructed immediately east of area.</p>

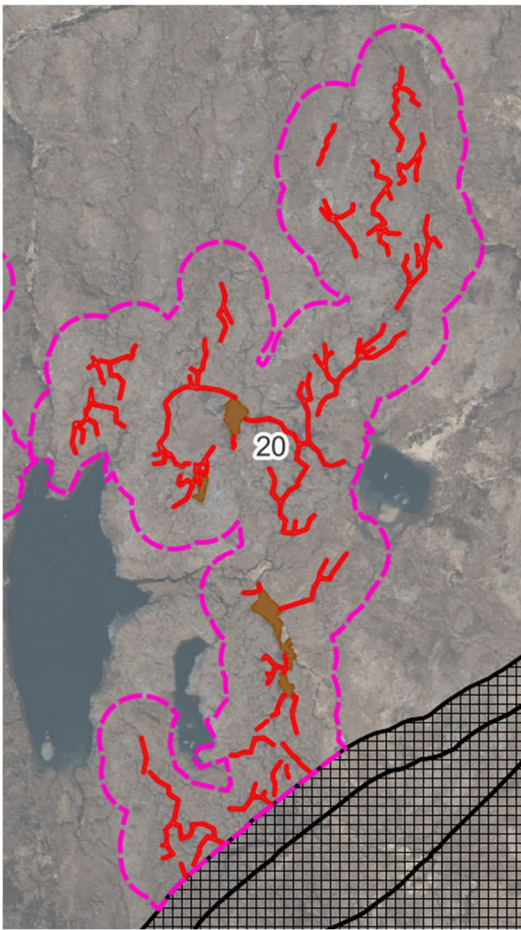
Restoration Area ID and Description	Recommended Restoration Techniques	Image
<p>Area ID: 20</p> <p>Grid reference: NH 44993 23450</p> <p>Areas: Restoration Area – 92,607 m² Bare peat – 894 m² Gullies – 4,744 m²</p> <p>Peat depth: Variable across area, at least one third >1 m depth, with majority of remainder 0.3-0.99 m, and small amounts <0.3 m.</p> <p>Description: Area is very expansive and comprises M15c/M17b/M19a/H16 (65/25/9.99/0.01), M15c/M17b (50/50 and 60/40), M17b/Peat/Rock (85/10/5), and M17b/Peat/M1/M2/M3 (97.5/1/0.5/0.5/0.5). Five areas of significant flat bare peat.</p>	<p>Restoration of eroded/bare areas using machine-based techniques.</p> <p>Access via new permanent tracks which will be constructed approximately 120 m south and 200 m north of area, and across intervening permanent construction and wet heath habitat.</p>

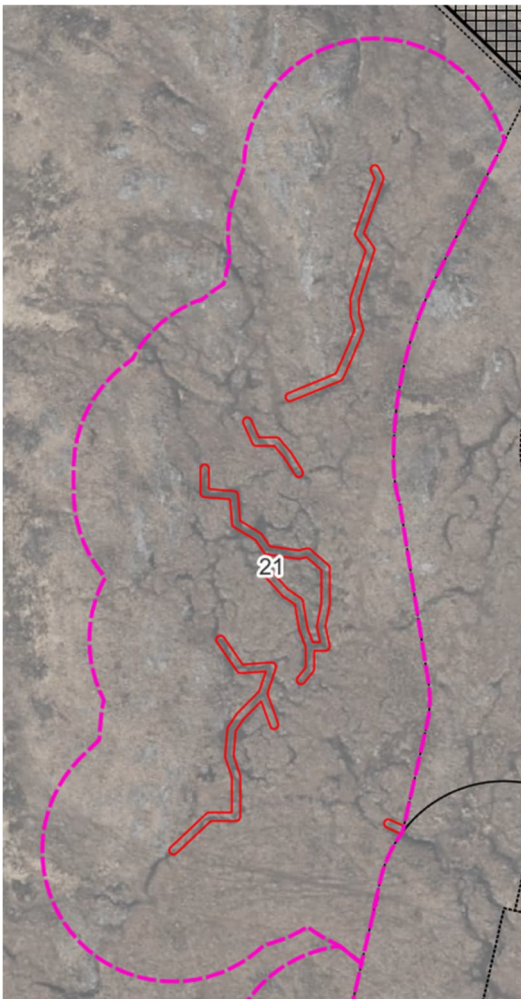
Restoration Area ID and Description	Recommended Restoration Techniques	Image
<p>Area ID: 21</p> <p>Grid reference: NH 45250 23627</p> <p>Areas: Restoration Area – 14,943 m² Gullies – 536 m²</p> <p>Peat depth: Area largely beyond peat probing, with small areas of 0.3-0.49 m and 0.5-0.99 m peat depth.</p> <p>Description: Majority of area comprises M17b/M15c/M19a/M17a/M2 (85/10/3/1.9/0.1), with small areas of M15c/H21 (98/2) surrounding. No significant areas of flat bare peat.</p>	<p>Restoration of eroded/bare areas using machine-based techniques.</p> <p>Access via new permanent track which will be constructed approximately 67 m north of area, and across intervening wet heath habitat.</p>

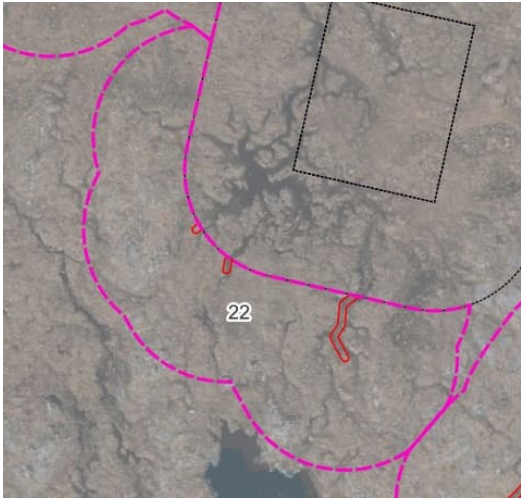
<p>Area ID: 22</p> <p>Grid reference: NH 45279 23458</p> <p>Areas: Restoration Area – 5,314 m² Gullies – 64 m²</p> <p>Peat depth: Area partially beyond peat probing, though half of the area has peat depth of 0.3-0.49 m.</p> <p>Description: Area comprises M17b/M15c/M19a/M17a/M2 (85/10/3/1.9/0.1). No significant areas of flat bare peat.</p>	<p>Restoration of eroded/bare areas using machine-based techniques.</p> <p>Access via new permanent track which will be constructed approximately 130 m north of area, and across intervening modified bog habitat.</p>

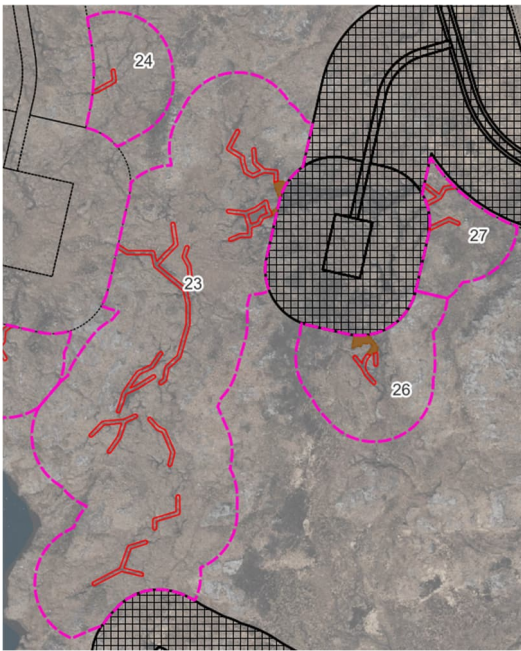
Restoration Area ID and Description	Recommended Restoration Techniques	Image
<p>Area ID: 23</p> <p>Grid reference: NH 45405 23484</p> <p>Areas: Restoration Area – 22,953 m² Bare peat – 44 m² Gullies – 971 m²</p> <p>Peat depth: Area partially beyond peat probing, though half of the area has peat depth of 0.5-0.99 m, and small pocket of >1 m.</p> <p>Description: Area comprises M17b/M15c/M19a/M17a/M2 (85/10/3/1.9/0.1) and M19/Peat (85/15), with one area of significant flat bare peat.</p>	<p>Restoration of eroded/bare areas using machine-based techniques.</p> <p>Access via new permanent track and/or surrounding areas of permanent construction</p>

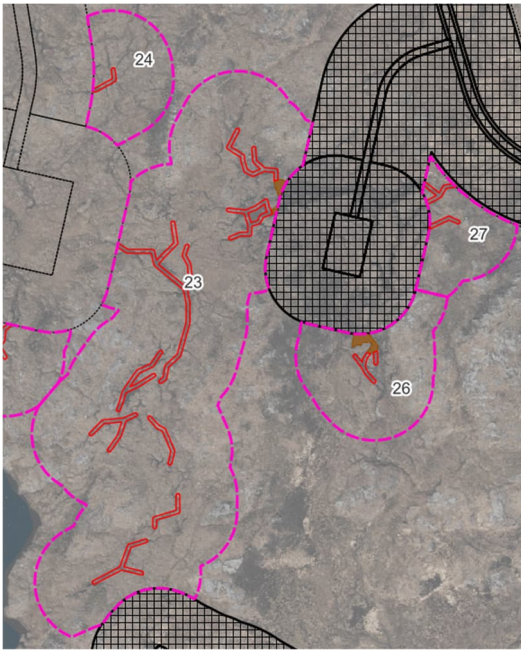
<p>Area ID: 24</p> <p>Grid reference: NH 45380 23601</p> <p>Areas: Restoration Area – 2,453 m² Gullies – 37 m²</p> <p>Peat depth: Area largely beyond peat probing, though small area has peat depth of 0.5-0.99 m.</p> <p>Description: Majority of area comprises M17b/M15c/M19a/M17a/M2 (85/10/3/1.9/0.1). No significant areas of flat bare peat.</p>	<p>Restoration of eroded/bare areas using machine-based techniques.</p> <p>Access via new permanent track and/or surrounding areas of permanent construction</p>

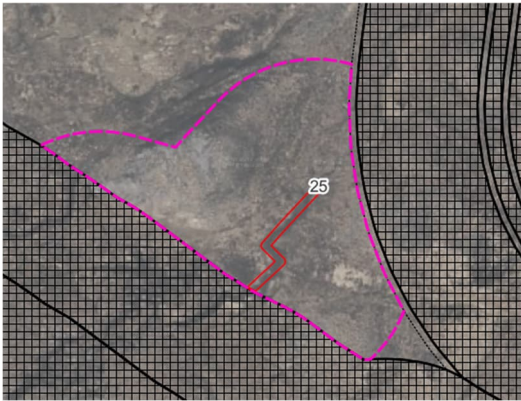
<p>Area ID: 25</p> <p>Grid reference: NH 45583 23250</p> <p>Areas: Restoration Area – 2,721 m² Gullies – 66 m²</p> <p>Peat depth: 0.5-0.99 m.</p> <p>Description: Area comprises M17b/M19a/Peat (70/29.9/0.1), no significant areas of flat bare peat.</p>	<p>Restoration of eroded/bare areas using machine-based techniques.</p> <p>Access via new permanent track which will be constructed immediately east of area.</p>

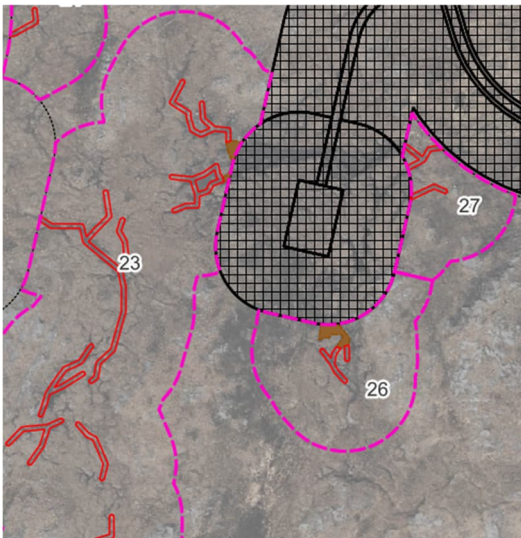
Restoration Area ID and Description	Recommended Restoration Techniques	Image
<p>Area ID: 26</p> <p>Grid reference: NH 45514 23428</p> <p>Areas: Restoration Area – 3,897 m² Bare peat – 71 m² Gullies – 63 m²</p> <p>Peat depth: Area largely beyond peat probing, with small area of 0.5-0.99 m peat depth joining Area 27.</p> <p>Description: Majority of area comprises M17b/M15c/M19a/M17a/M2 (85/10/3/1.9/0.1) and M19/Peat (85/15), including two significant areas of flat bare peat.</p>	<p>Restoration of eroded/bare areas using machine-based techniques.</p> <p>Access via new permanent track and/or surrounding areas of permanent construction.</p>

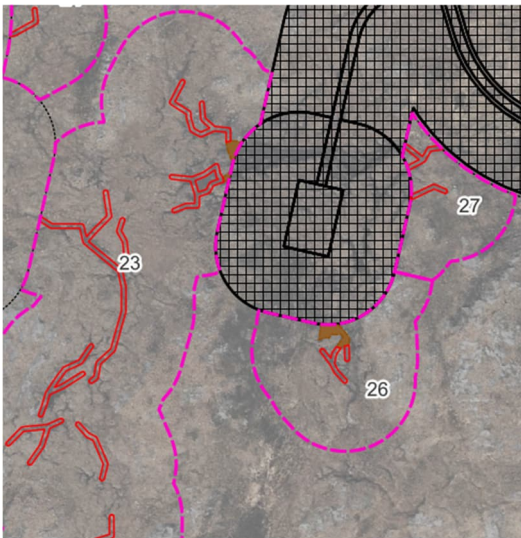
<p>Area ID: 27</p> <p>Grid reference: NH 45555 23509</p> <p>Areas: Restoration Area – 2,075 m² Gullies – 89 m²</p> <p>Peat depth: 0.5-0.99 m.</p> <p>Description: Majority of area comprises M17b/M15c/M19a/M17a/M2 (85/10/3/1.9/0.1) and M19/Peat (85/15). No significant areas of flat bare peat.</p>	<p>Restoration of eroded/bare areas using machine-based techniques.</p> <p>Access via new permanent track and/or surrounding areas of permanent construction.</p>

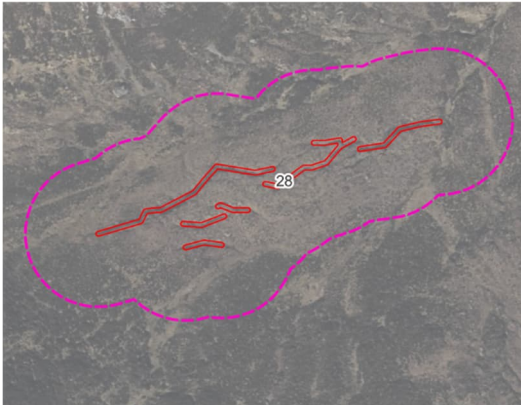
<p>Area ID: 28</p> <p>Grid reference: NH 46044 23125</p> <p>Areas: Restoration Area – 14,445 m² Gullies – 473 m²</p> <p>Peat depth: Majority of area has peat depth of 0.3-0.49 m, with remainder <0.3 m.</p> <p>Description: Area largely located within M19a/M17b (80/20), with smaller amounts of M19a/H21a (50/50) and M15a/H21a/M10a (45/45/10). No significant areas of flat bare peat present.</p>	<p>Restoration of eroded/bare areas using machine-based techniques.</p> <p>Access via new permanent track which will be constructed approximately 250 m west of area, and across intervening wet heath and modified bog habitat.</p>

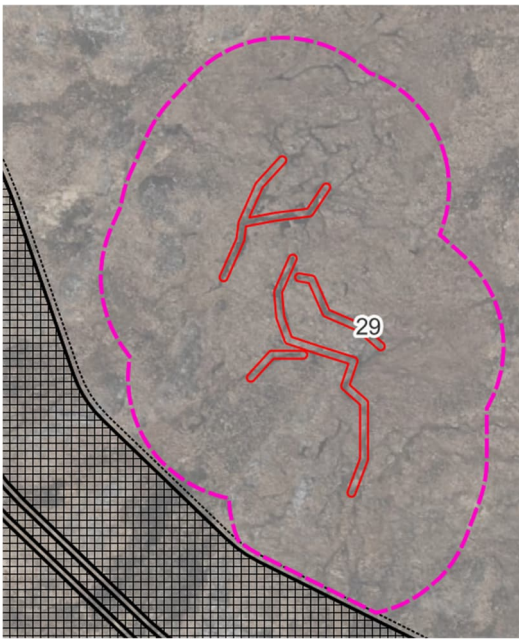
Restoration Area ID and Description	Recommended Restoration Techniques	Image
<p>Area ID: 29</p> <p>Grid reference: NH 45390 23842</p> <p>Areas: Restoration Area – 10,533 m² Gullies – 368 m²</p> <p>Peat depth: Majority of area has peat depth of 0.3-0.49 m, with small amount of 0.5-0.99 m.</p> <p>Description: Majority of area comprises M17b/M15c/M19a/M1/M2 (71/20/10/5/2/2), with small amounts of M15c/M19c (80/20) and M15c/M19c/H12b/ H16 (95/4.8/0.1/0.1) around edges. No significant areas of flat bare peat.</p>	<p>Restoration of eroded/bare areas using machine-based techniques.</p> <p>Access via new permanent track which will be constructed immediately south of area.</p>

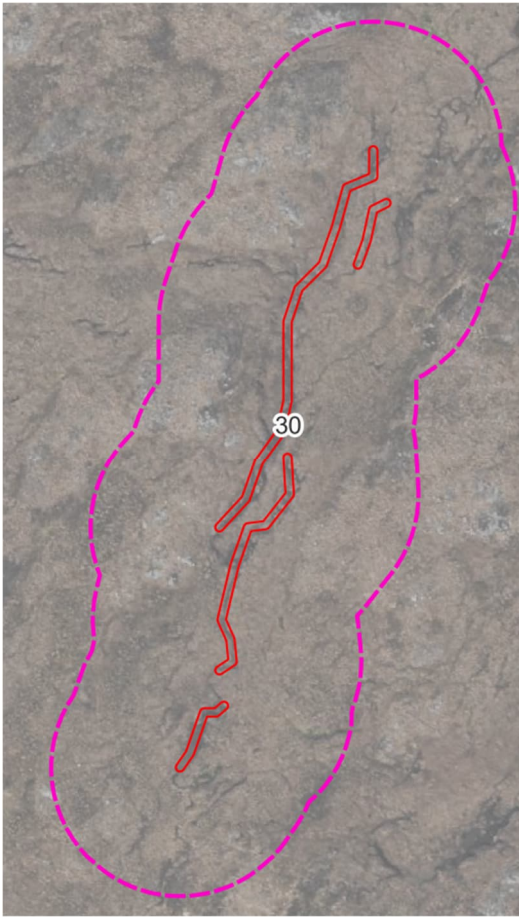
<p>Area ID: 30</p> <p>Grid reference: NH 45566 23906</p> <p>Areas: Restoration Area – 13,757 m² Gullies – 415 m²</p> <p>Peat depth: Area largely beyond peat probing, though some areas of >1 m and 0.5-0.99 m peat depth.</p> <p>Description: Gullies are located within M15c/M19c/ M15b/M17a/M2 (40/40/10/9.8/0.2) with surrounding M15c/M19c/Rock/H16 (87/10/2/1) and M15c/M19c/M15b/M17a/M2 (40/40/10/9.8/0.2). No significant areas of flat bare peat.</p>	<p>Restoration of eroded/bare areas using machine-based techniques.</p> <p>Access via new permanent track which will be constructed approximately 150 m south of area and across intervening modified bog or wet heath habitat.</p>

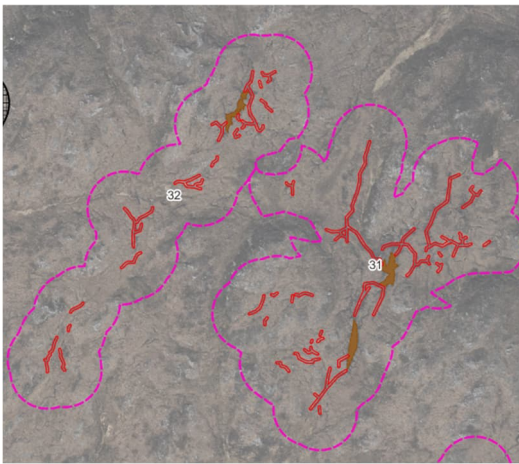
Restoration Area ID and Description	Recommended Restoration Techniques	Image
<p>Area ID: 31</p> <p>Grid reference: NH 45501 24146</p> <p>Areas: Restoration Area – 40,014 m² Bare peat – 355 m² Gullies – 1,589 m²</p> <p>Peat depth: Area beyond peat probing.</p> <p>Description: Gullies located within M15c/M19a/Peat/Rock (50/49.4/0.5/0.1), M19a/Peat (97/3 and 60/40), and M15c/M19c/Rock (79/20/1), with two large areas of flat bare peat. There is also M15c/M19c/Rock/H16 of varying proportions in the surrounds.</p>	<p>Restoration of eroded/bare areas using machine-based techniques.</p> <p>Access via new permanent track which will be constructed approximately 250 m south west of area and across intervening wet heath habitat.</p>

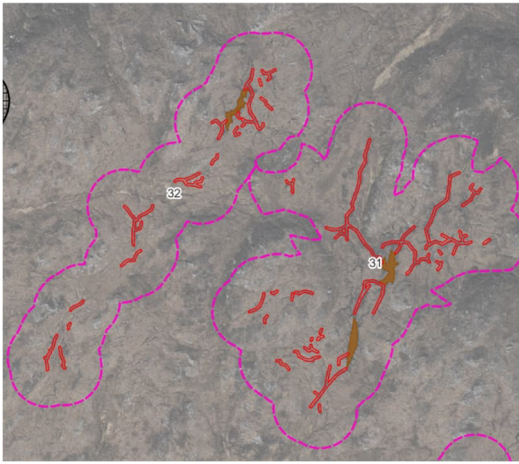
<p>Area ID: 32</p> <p>Grid reference: NH 45332 24204</p> <p>Areas: Restoration Area – 27,391 m² Bare peat – 140 m² Gullies – 807 m²</p> <p>Peat depth: Area beyond peat probing.</p> <p>Description: Gullies located within M15c/M19a/Peat/Rock (50/49.4/0.5/0.1) and M15c/M19c (80/20), including one large area of flat bare peat. There are also small amounts of M15c/M19a/Rock (50/49.9/0.1) around edges.</p>	<p>Restoration of eroded/bare areas using machine-based techniques.</p> <p>Access via new permanent track which will be constructed approximately 150 m south west of area and across intervening wet heath habitat.</p>

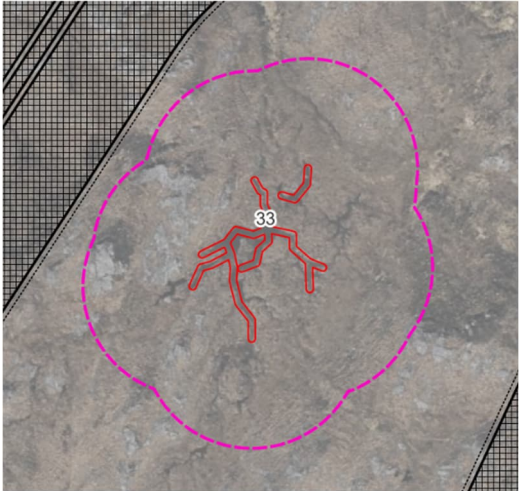
<p>Area ID: 33</p> <p>Grid reference: NH 44983 24303</p> <p>Areas: Restoration Area – 8,054 m² Gullies – 283 m²</p> <p>Peat depth: Area largely beyond peat probing, though some areas of 0.3-0.49 m peat depth.</p> <p>Description: Gullies located within M17b (100), surrounded by M15c/M19c/H12b/H16 (95/4.8/0.1/0.1) around edges. No significant areas of flat bare peat.</p>	<p>Restoration of eroded/bare areas using machine-based techniques.</p> <p>Access via new permanent track which will be constructed west of area.</p>

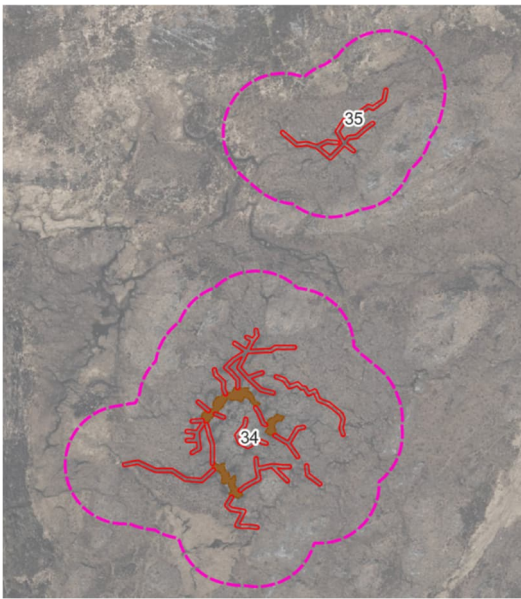
Restoration Area ID and Description	Recommended Restoration Techniques	Image
<p>Area ID: 34</p> <p>Grid reference: NH 45626 24980</p> <p>Areas: Restoration Area – 18,916 m² Bare peat – 291 m² Gullies – 983 m²</p> <p>Peat depth: Area largely beyond peat probing, though some areas of 0.3-0.49 m and 0.5-0.99 m peat depth.</p> <p>Description: Majority of area comprises M17b/M17a/ M15c/Peat (70/10/10/10) with three significant areas of flat bare peat. Small amounts of M15a/M25a (90/10) and M15a/M17a (50/50) in the wider area.</p>	<p>Restoration of eroded/bare areas using machine-based techniques.</p> <p>Access via new permanent track which will be constructed approximately 170 m south of area and across intervening modified bog or wet heath habitat.</p>

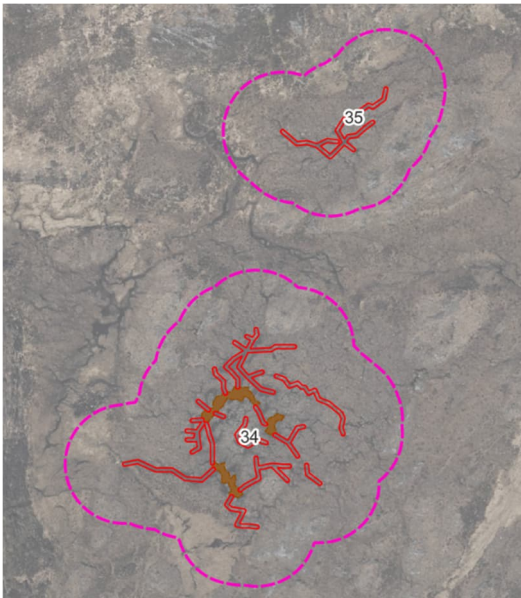
<p>Area ID: 35</p> <p>Grid reference: NH 45681 25147</p> <p>Areas: Restoration Area – 7,865 m² Gullies – 243 m²</p> <p>Peat depth: Some of area beyond peat probing, though around half of area has 0.3-0.49 m and some 0.5-0.99 m peat depth.</p> <p>Description: Majority of area comprises M17b/Peat (99/1), though no significant areas of flat bare peat. Remainder of area comprises M15c/M17a/ M17b/Rock (69/15/15/1).</p>	<p>Restoration of eroded/bare areas using machine-based techniques.</p> <p>Access via new permanent track which will be constructed approximately 370 m south of area and across intervening modified bog or wet heath habitat.</p>

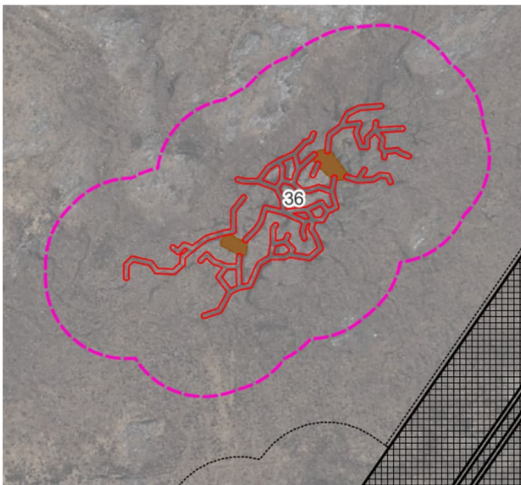
<p>Area ID: 36</p> <p>Grid reference: NH 46166 25519</p> <p>Areas: Restoration Area – 15,132 m² Bare peat – 131 m² Gullies – 1,050 m²</p> <p>Peat depth: Depth variable across area, though mostly 0.5-0.99 m, with small amounts of >1 m peat depth.</p> <p>Description: Majority of area comprises M17b/M19a/Peat (75/20/5) with two areas of significant flat bare peat. Remainder of areas comprises M15c/ M19a/M17b/Rock (95/2/2/1).</p>	<p>Restoration of eroded/bare areas using machine-based techniques.</p> <p>Access via new permanent track which will be constructed approximately 10 m east of area.</p>

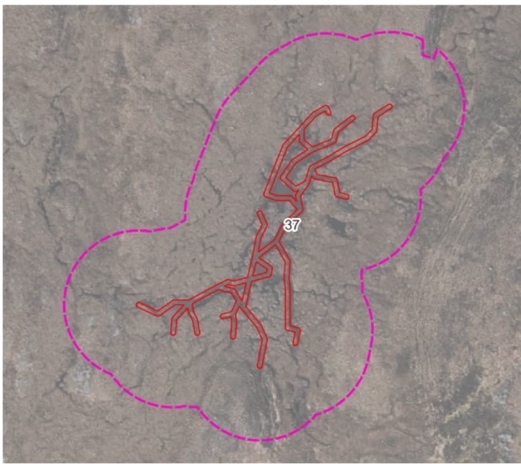
Restoration Area ID and Description	Recommended Restoration Techniques	Image
<p>Area ID: 37</p> <p>Grid reference: NH 44739 21449</p> <p>Areas: Restoration Area – 16,698 m² Gullies – 949 m²</p> <p>Peat depth: Majority of area has peat depth of >1 m, with small amount of 0.5-0.99 m.</p> <p>Description: Area comprises M17b/M19c/M2 (50/49.8/0.2) and M19c/Peat (50/50), however, no significant areas of flat bare peat.</p>	<p>Restoration of eroded/bare areas using machine-based techniques.</p> <p>Access via new permanent track which will be constructed approximately 480 m north of area and across intervening permanent construction or modified bog and wet heath habitat.</p>

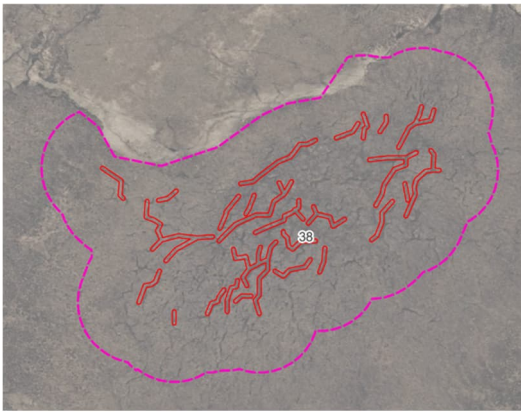
<p>Area ID: 38</p> <p>Grid reference: NH 46712 24159</p> <p>Areas: Restoration Area – 24,872 m² Gullies – 1,532 m²</p> <p>Peat depth: Majority of area has peat depth of >1 m, with small amount of 0.5-0.99 m.</p> <p>Description: Area comprises M19a/M17a/M17b (80/10/10). No significant areas of flat bare peat.</p>	<p>Restoration of eroded/bare areas using hand techniques and helicoptered materials.</p> <p>Access via new permanent track which will be constructed approximately 700 m north west of area and across intervening modified bog or wet heath habitat. If topography proves a constraint, potential access via an existing track 1.5 km north east across intervening modified bog or wet heath habitat. Stream crossing points to be considered.</p>

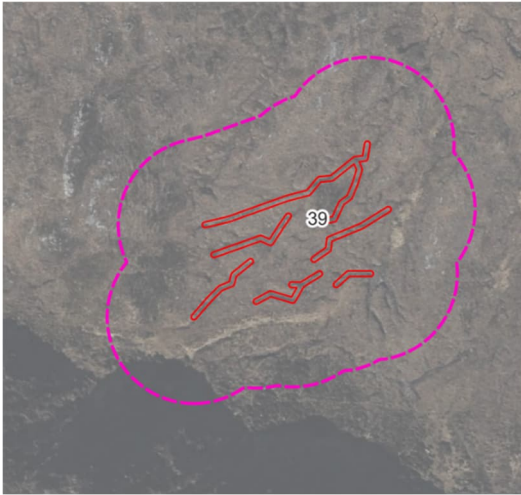
<p>Area ID: 39</p> <p>Grid reference: NH 43836 23498</p> <p>Areas: Restoration Area – 11,872 m² Gullies – 502 m²</p> <p>Peat depth: Area beyond peat probing.</p> <p>Description: Around half of area not surveyed, but remainder comprises M15c/M17a/M19c/M15a/M15b (45/45/8/1/1) and small amount of M15c/M19c/Rock (85/10/5). No significant areas of flat bare peat.</p>	<p>Restoration of eroded/bare areas using machine-based techniques.</p> <p>Access via new permanent track which will be constructed approximately 380 m east of area and across intervening wet heath habitat.</p>

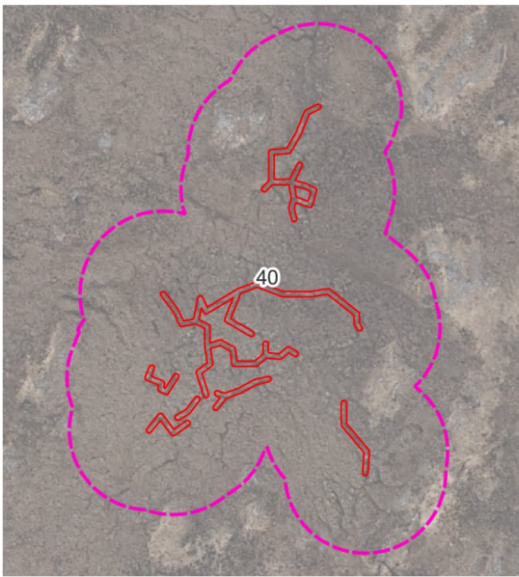
Restoration Area ID and Description	Recommended Restoration Techniques	Image
<p>Area ID: 40</p> <p>Grid reference: NH 44151 21190</p> <p>Areas: Restoration Area – 19,260 m² Gullies – 807 m²</p> <p>Peat depth: Area beyond peat probing.</p> <p>Description: Area comprises M17b/M19a (50/50). No significant areas of flat bare peat.</p>	<p>Restoration of eroded/bare areas using machine-based techniques.</p> <p>Access via new permanent track which will be constructed approximately 700 m north west or via new track 750 m north east of area and across intervening modified bog or wet heath habitat.</p>

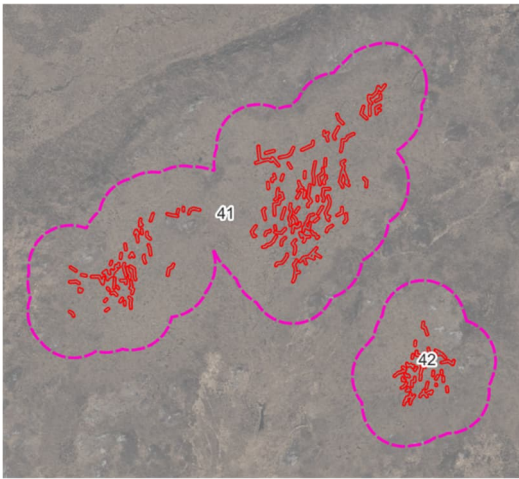
<p>Area ID: 41</p> <p>Grid reference: NH 46983 25465</p> <p>Areas: Restoration Area – 36,408 m² Gullies – 2,062 m²</p> <p>Peat depth: Some of area beyond peat probing, but large area has peat depth of >1 m, with good amount of 0.5-0.99 m.</p> <p>Description: Outside NVC survey area. No significant areas of flat bare peat evident from aerial imagery.</p>	<p>Restoration of eroded/bare areas using hand techniques and helicoptered materials.</p> <p>Access via existing forestry track approximately 800 m east and accessed via Bunloit Road, Balbeg. Otherwise, potential access via new track 580 m north east of area and across intervening modified bog or wet heath habitat, however topography and presence of a watercourse may constrain this route.</p>

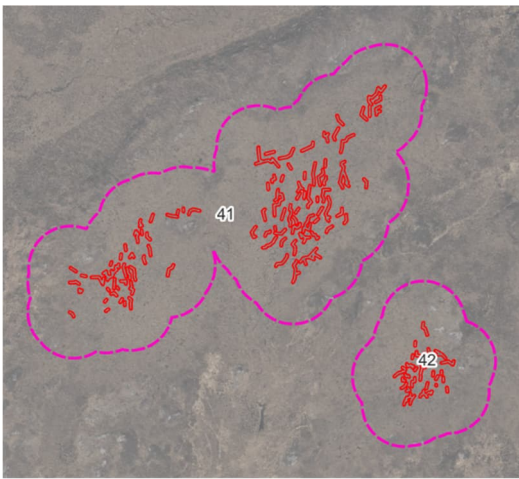
<p>Area ID: 42</p> <p>Grid reference: NH 47132 25357</p> <p>Areas: Restoration Area – 9,392 m² Gullies – 453 m²</p> <p>Peat depth: Area beyond peat probing.</p> <p>Description: Outside NVC survey area. No significant areas of flat bare peat evident from aerial imagery.</p>	<p>Restoration of eroded/bare areas using hand techniques and helicoptered materials.</p> <p>Access via existing forestry track approximately 800 m east and accessed via Bunloit Road, Balbeg. Otherwise, potential access via new track 580 m north east of area and across intervening modified bog or wet heath habitat, however topography and presence of a watercourse may constrain this route.</p>

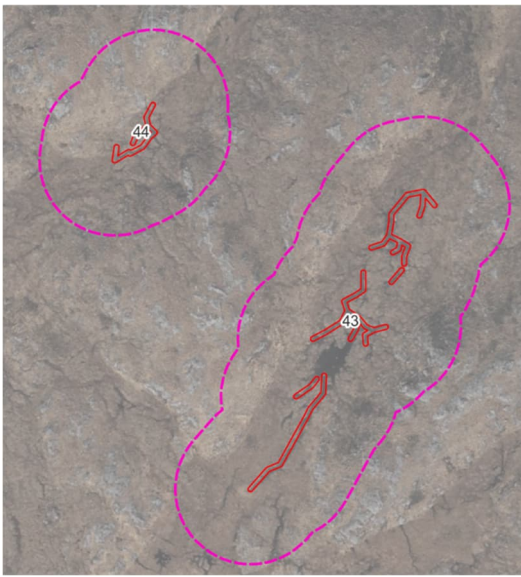
Restoration Area ID and Description	Recommended Restoration Techniques	Image
<p>Area ID: 43</p> <p>Grid reference: NH 42794 21505</p> <p>Areas: Restoration Area – 13,720 m² Gullies – 465 m²</p> <p>Peat depth: Area beyond peat probing.</p> <p>Description: Outside NVC survey area. No significant areas of flat bare peat evident from aerial imagery.</p>	<p>Restoration of eroded/bare areas using machine-based techniques.</p> <p>Access via existing track (which will join to new permanent track) located approximately 640 m east of area and across intervening wet heath habitat, heading north of lochan. Stream crossing point to be considered.</p>

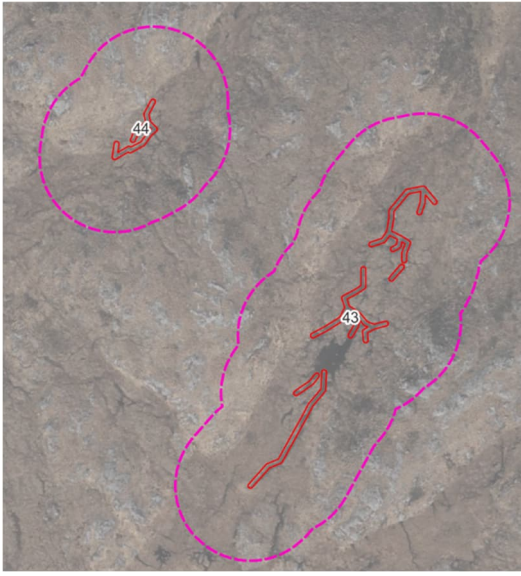
<p>Area ID: 44</p> <p>Grid reference: NH 42707 21583</p> <p>Areas: Restoration Area – 5,042 m² Gullies – 102 m²</p> <p>Peat depth: Area beyond peat probing.</p> <p>Description: Outside NVC survey area. No significant areas of flat bare peat evident from aerial imagery.</p>	<p>Restoration of eroded/bare areas using machine-based techniques.</p> <p>Access via existing track (which will join to new permanent track) located approximately 750 m east of area and across intervening wet heath habitat, heading north of lochan. Stream crossing point to be considered.</p>

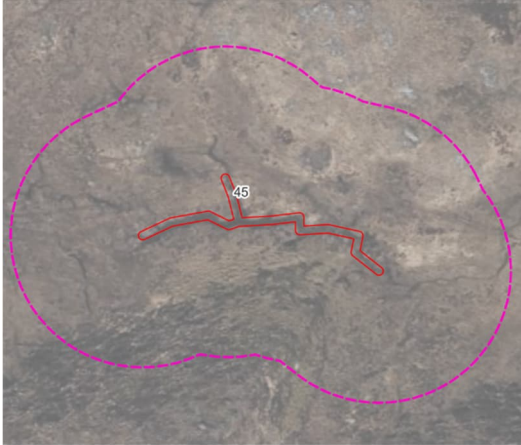
<p>Area ID: 45</p> <p>Grid reference: NH 42742 21711</p> <p>Areas: Restoration Area – 7,158 m² Gullies – 157 m²</p> <p>Peat depth: Area beyond peat probing.</p> <p>Description: Outside NVC survey area. No significant areas of flat bare peat evident from aerial imagery.</p>	<p>Restoration of eroded/bare areas using machine-based techniques.</p> <p>Access via existing track (which will join to new permanent track) located approximately 750 m east of area and across intervening wet heath habitat, heading north of lochan. Stream crossing point to be considered.</p>

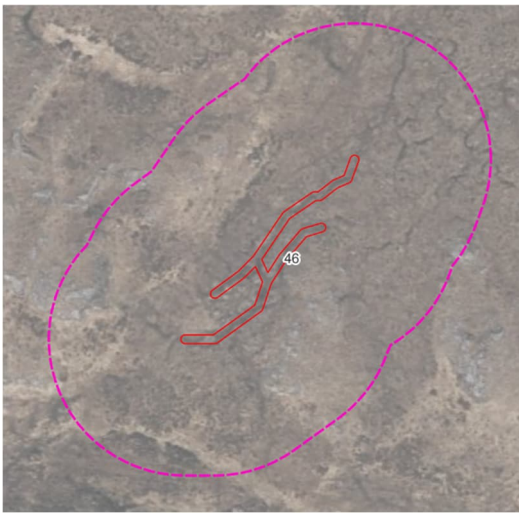
Restoration Area ID and Description	Recommended Restoration Techniques	Image
<p>Area ID: 46</p> <p>Grid reference: NH 42959 21732</p> <p>Areas: Restoration Area – 6,933 m² Gullies – 191 m²</p> <p>Peat depth: Area beyond peat probing.</p> <p>Description: Outside NVC survey area. No significant areas of flat bare peat evident from aerial imagery.</p>	<p>Restoration of eroded/bare areas using machine-based techniques.</p> <p>Access via existing track (which will join to new permanent track) located approximately 620 m east of area and across intervening wet heath habitat, heading north of lochan. Stream crossing point to be considered.</p>

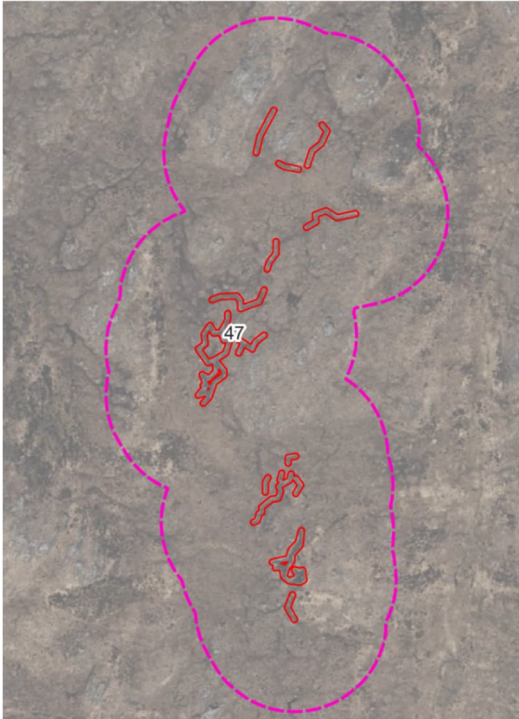
<p>Area ID: 47</p> <p>Grid reference: NH 42532 21926</p> <p>Areas: Restoration Area – 17,980 m² Gullies – 622 m²</p> <p>Peat depth: Area beyond peat probing.</p> <p>Description: Outside NVC survey area. No significant areas of flat bare peat evident from aerial imagery.</p>	<p>Restoration of eroded/bare areas using machine-based techniques.</p> <p>Access via existing track (which will join to new permanent track) located approximately 1 km east of area and across intervening wet heath habitat, heading north of lochan. Stream crossing point to be considered.</p>
