Glen Earrach Pumped Storage Hydro

Environmental Impact Assessment Report

Volume 5: Appendices
Appendix 7.6: Outline Peatland Restoration Plan

Glen Earrach Energy Ltd

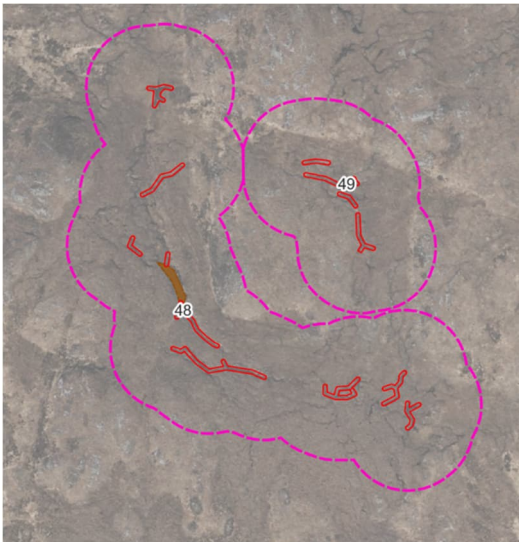
<p>Area ID: 48</p> <p>Grid reference: NH 42911 22573</p> <p>Areas: Restoration Area – 21,887 m² Bare peat – 74 m² Gullies – 510 m²</p> <p>Peat depth: Area beyond peat probing.</p> <p>Description: Outside NVC survey area. One significant area of flat bare peat evident from aerial imagery.</p>	<p>Restoration of eroded/bare areas using machine-based techniques.</p> <p>Access via new permanent track which will be constructed approximately 890 m east of area and across intervening wet heath habitat. Stream crossing point to be considered.</p>

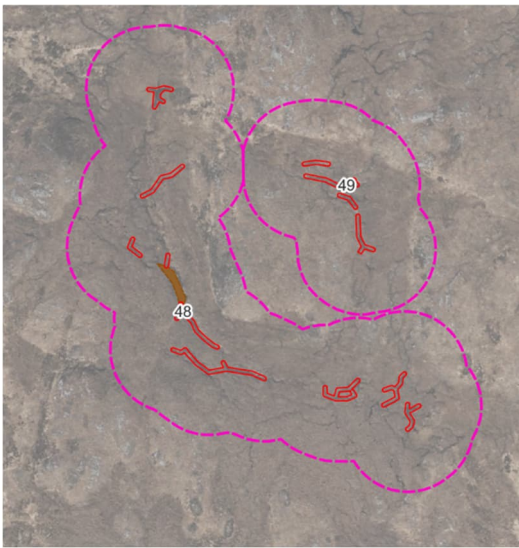
Restoration Area ID and Description	Recommended Restoration Techniques	Image
<p>Area ID: 49</p> <p>Grid reference: NH 42992 22636</p> <p>Areas: Restoration Area – 7,252 m² Gullies – 161 m²</p> <p>Peat depth: Area beyond peat probing.</p> <p>Description: Outside NVC survey area. No significant areas of flat bare peat evident from aerial imagery.</p>	<p>Restoration of eroded/bare areas using machine-based techniques.</p> <p>Access via new permanent track which will be constructed approximately 960 m east of area and across intervening wet heath habitat.</p>

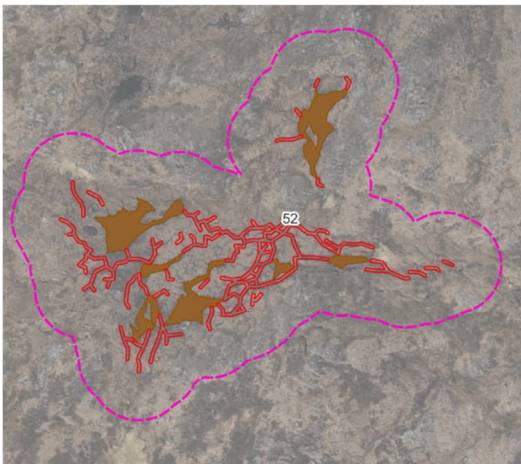
Restoration Area ID and Description	Recommended Restoration Techniques	Image
<p>Area ID: 52</p> <p>Grid reference: NH 43834 23007</p> <p>Areas: Restoration Area – 41,356 m² Bare peat – 2,369 m² Gullies – 2,219 m²</p> <p>Peat depth: Area partially beyond peat probing. Significant area of 0.5-0.99 m peat depth, with some 0.3-0.49 m depth.</p> <p>Description: Outside NVC survey area. Five significant areas of flat bare peat evident from aerial imagery.</p>	<p>Restoration of eroded/bare areas using machine-based techniques.</p> <p>Access via new permanent track which will be constructed approximately 580 m east of area and across intervening wet heath habitat.</p>

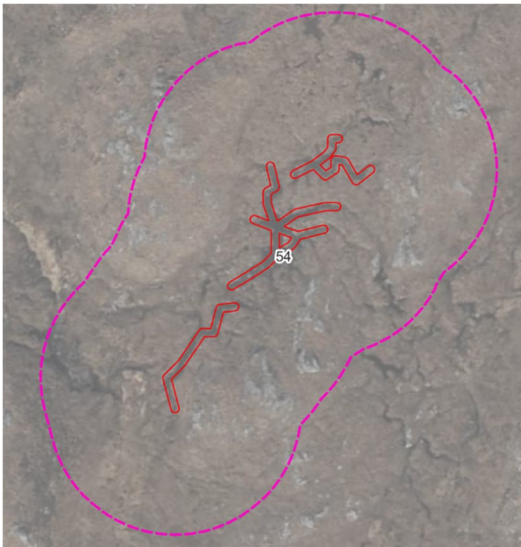
<p>Area ID: 54</p> <p>Grid reference: NH 43033 23738</p> <p>Areas: Restoration Area – 8,977 m² Gullies – 300 m²</p> <p>Peat depth: Area beyond peat probing.</p> <p>Description: Outside NVC survey area. No significant areas of flat bare peat evident from aerial imagery.</p>	<p>Restoration of eroded/bare areas using machine-based techniques.</p> <p>Access potentially via new permanent track which will be constructed approximately 1.2 km east of area, if intervening land is suitable.</p>

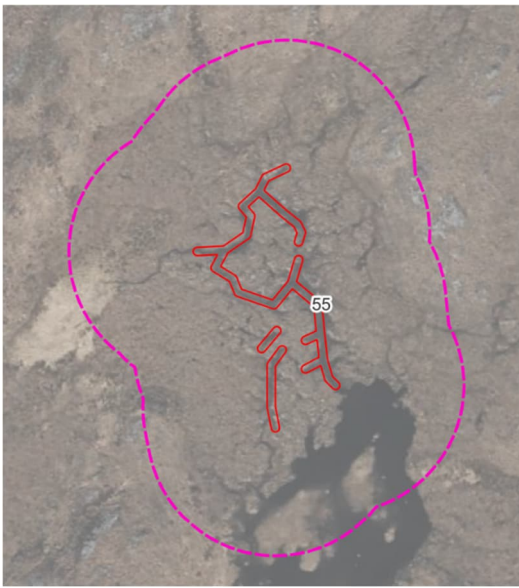
Restoration Area ID and Description	Recommended Restoration Techniques	Image
<p>Area ID: 55</p> <p>Grid reference: NH 42995 24038</p> <p>Areas: Restoration Area – 8,571 m² Gullies – 307 m²</p> <p>Peat depth: Area beyond peat probing.</p> <p>Description: Outside NVC survey area. No significant areas of flat bare peat evident from aerial imagery.</p>	<p>Restoration of eroded/bare areas using machine-based techniques.</p> <p>Access potentially via new permanent track which will be constructed approximately 1.2 km east of area, if intervening land is suitable.</p>

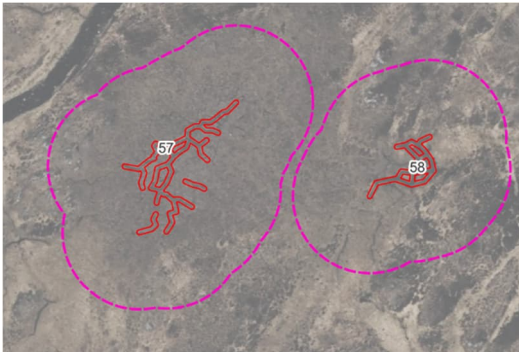
<p>Area ID: 57</p> <p>Grid reference: NH 43297 25232</p> <p>Areas: Restoration Area – 8,706 m² Gullies – 722 m²</p> <p>Peat depth: Area beyond peat probing.</p> <p>Description: Outside NVC survey area. No significant areas of flat bare peat evident from aerial imagery.</p>	<p>Restoration of eroded/bare areas using hand techniques and helicoptered materials.</p> <p>Access potentially via new permanent track which will be constructed approximately 1.8 km south east of area, if intervening land is suitable.</p>

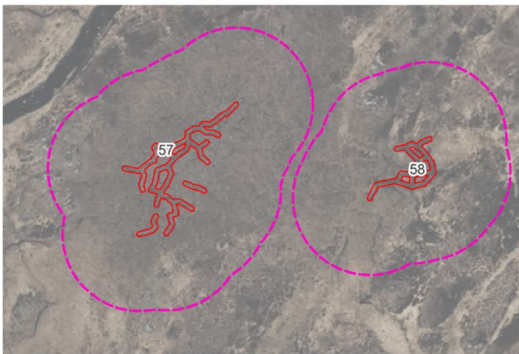
Restoration Area ID and Description	Recommended Restoration Techniques	Image
<p>Area ID: 58</p> <p>Grid reference: NH 43398 25224</p> <p>Areas: Restoration Area – 5,771 m² Gullies – 366 m²</p> <p>Peat depth: Area beyond peat probing.</p> <p>Description: Outside NVC survey area. No significant areas of flat bare peat evident from aerial imagery.</p>	<p>Restoration of eroded/bare areas using hand techniques and helicoptered materials.</p> <p>Access potentially via new permanent track which will be constructed approximately 1.7 km south east of area, if intervening land is suitable.</p>

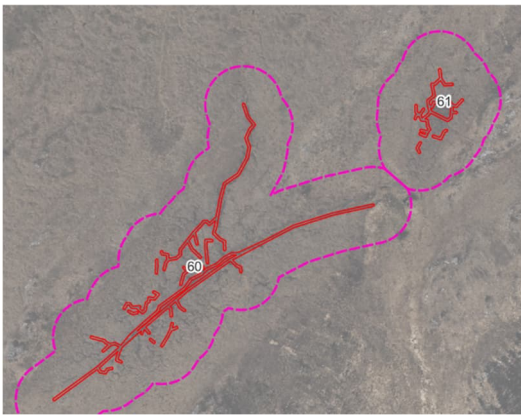
Restoration Area ID and Description	Recommended Restoration Techniques	Image
<p>Area ID: 61</p> <p>Grid reference: NH 43844 26467</p> <p>Areas: Restoration Area – 9,305 m² Gullies – 837 m²</p> <p>Peat depth: Area beyond peat probing.</p> <p>Description: Outside NVC survey area. No significant areas of flat bare peat evident from aerial imagery.</p>	<p>Restoration of eroded/bare areas using hand techniques and helicoptered materials.</p> <p>Personnel access via ATV.</p> <p>Top of a fairly steep area with river at bottom. Closest permanent track is 2 km east.</p>
