Glen Earrach Pumped Storage Hydro

Environmental Impact Assessment Report

Appendix 10.3: Geomorphic Baseline and Watercourse Crossings

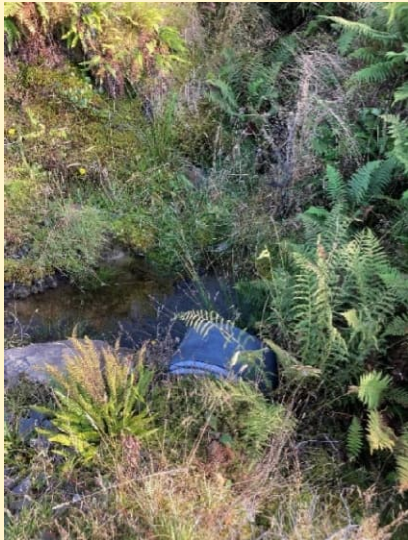
ID, NGR and Crossing Type	Description	Upstream	Downstream
SW29 Crossing 1 NH47010 29652 Type 1/Type 2 – Closed Pipe	<p>Existing watercourse crossing of an unnamed tributary to Allt Luirg nam Broc.</p> <p>The crossing is a corrugated pipe, located on the existing FLS access track.</p> <p>The small tributary channel appears relatively natural in form, flowing down the steep hillside with small gravel visible in the bed.</p>

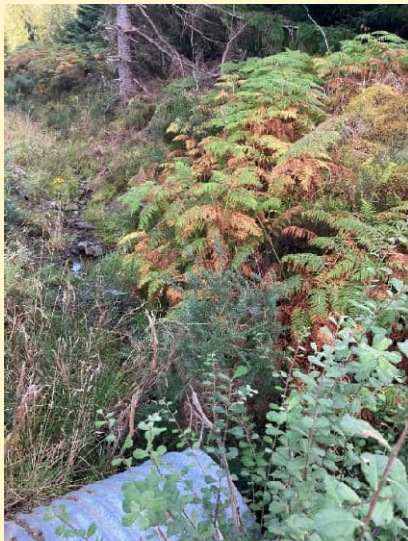
<p><i>No Associated Photographs</i></p>
SW30 Crossing 1 NH47599 29698 Type 1/Type 2 – Closed Pipe	<p>Existing watercourse crossing of a small unnamed watercourse.</p> <p>The crossing is a corrugated pipe, located on the existing FLS access track.</p> <p>The watercourse here is very small with very little flow seen on the day of inspection. The channel appears relatively natural in form, with small gravel contained in the bed.</p>

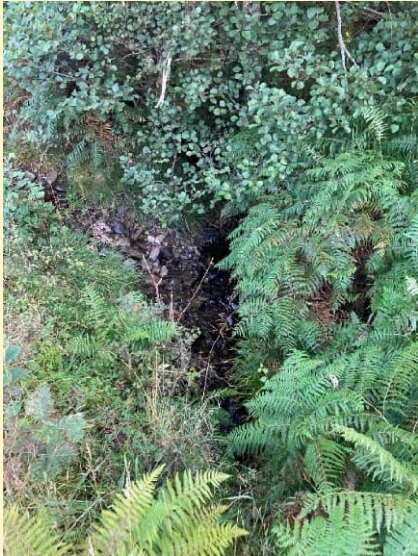
ID, NGR and Crossing Type	Description	Upstream	Downstream
SW25 Crossing 1 NH47940 29438 Type 1/Type 2 – Closed Pipe	Existing watercourse crossing of Drumclune Burn. The crossing is located on the existing FLS access track. The channel banks were heavily vegetated at the time of the site visit and therefore the channel was difficult to view. From what was visible, the channel contained small gravels and flowed naturally down the hillside.

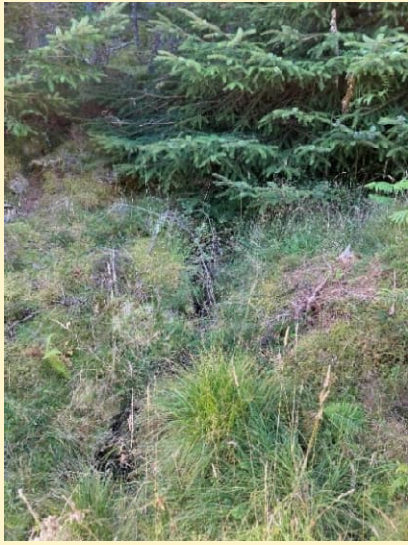
ID, NGR and Crossing Type	Description	Upstream	Downstream
<p>SW18 Crossing 1</p> <p>NH47412 27489</p> <p>Type 1/Type 2 – Closed Pipe</p>	<p>Existing watercourse crossing of unnamed tributary to the River Coiltie.</p> <p>The crossing is located on the existing FLS access track.</p> <p>The channel banks were heavily vegetated at the time of the site visit and therefore the channel was difficult to view. From what was visible, the channel appeared to contain small gravel and flowed from the steep valley side.</p>

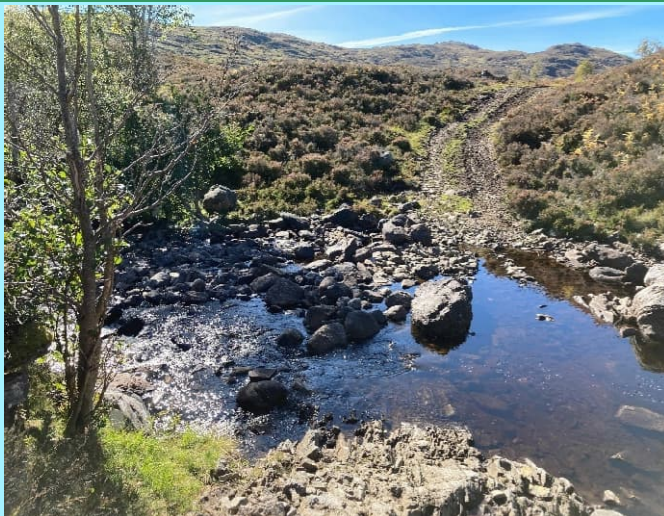
ID, NGR and Crossing Type	Description	Upstream	Downstream
SW9 Crossing 1 NH46489 26715 Type 3 – Bottomless Culvert	<p>Proposed watercourse crossing to replace the existing ford on the River Coiltie.</p> <p>Upstream of this area is an impoundment structure for a run of river hydropower scheme, which alters the natural flow regime in the affected reach. The channel is relatively unconfined in the vicinity of the crossing. The gradient steepens downstream and there is bedrock and large stable boulders present within the channel bed. The banks are lined with moorland vegetation and trees.</p>

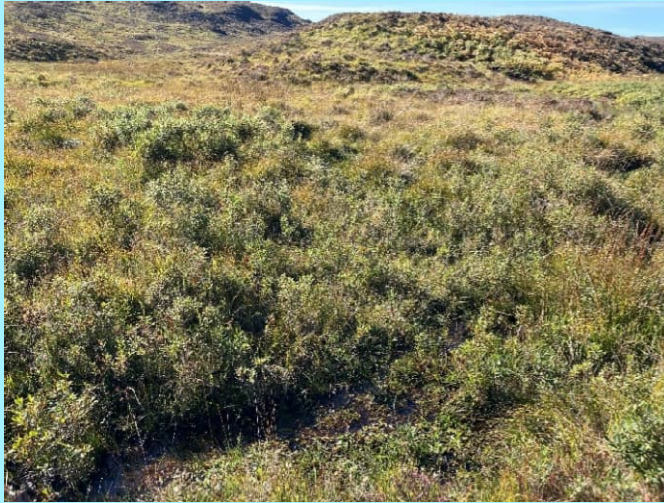
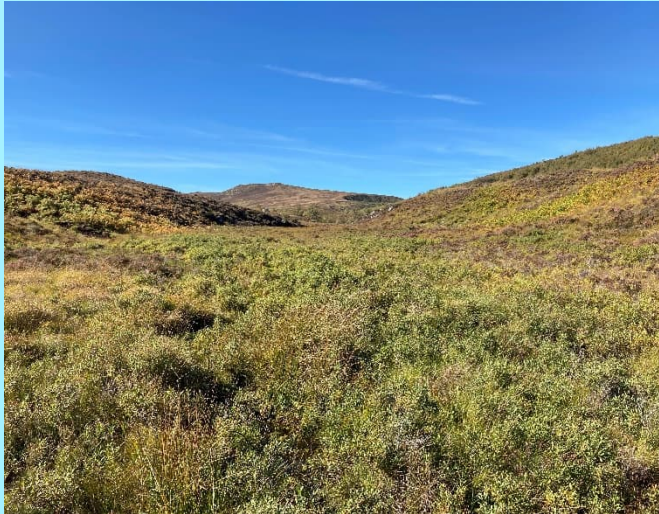
<p>Photographs taken approximately 50 m upstream of the crossing location.</p>

<p>No Associated Photographs</p>
SW12-C Crossing 1 NH 46026 26415 Type 3 – Bottomless Culvert	<p>Proposed access track watercourse crossing of an unnamed tributary to the River Coiltie.</p> <p>This is a small natural watercourse forming from runoff reaching the low point in the topography. The channel is poorly defined but some gravel and silt are present.</p>

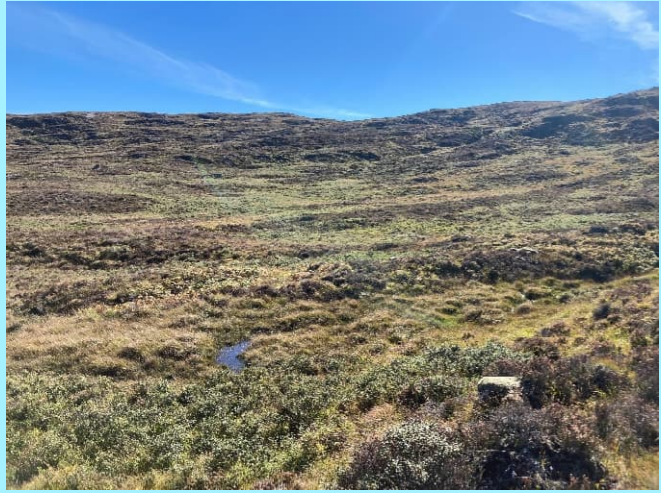
ID, NGR and Crossing Type	Description	Upstream	Downstream
SW12-C Crossing 2 NH 45962 26352 Type 3 – Bottomless Culvert	<p>Proposed access track watercourse crossing of un-named tributary to the River Coiltie.</p> <p>This is a small natural watercourse forming from runoff reaching the low point in the topography. The channel is poorly defined but some gravel and silt are present.</p>

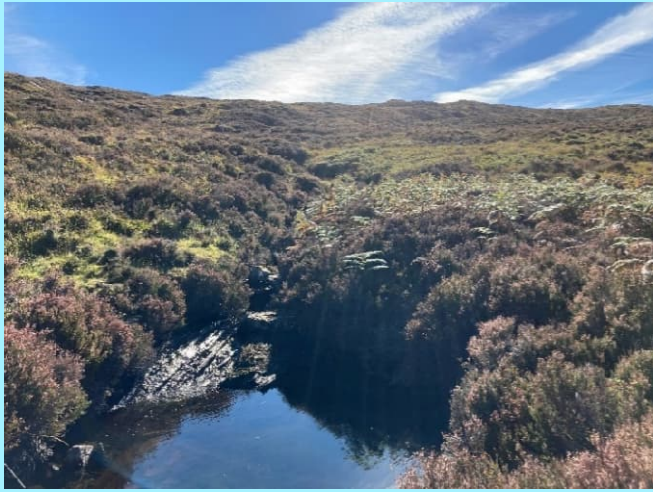
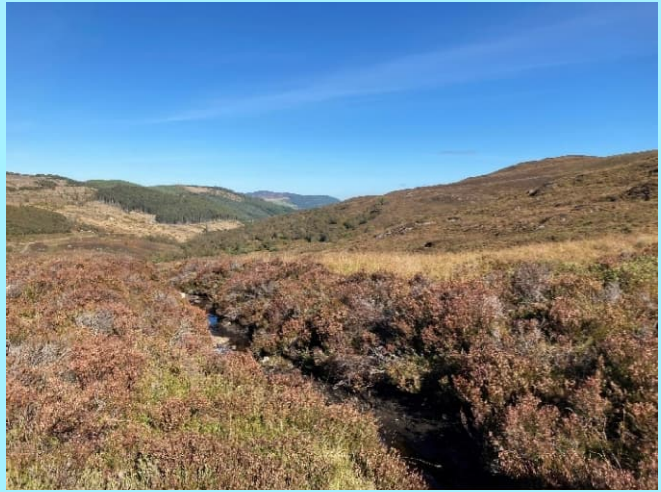
<p>Photograph taken approximately 100 m upstream of crossing location.</p>
SW12-B Crossing 1 NH 46185 26070 Type 3 – Bottomless Culvert	<p>Proposed access track watercourse crossing of un-named tributary to Allt Glas Beag.</p> <p>This small watercourse is located in an area of peaty soil. Bedrock is visible in some parts of the channel. The reach viewed on site had varied cross section widths and some transportable gravel was visible within the channel.</p>

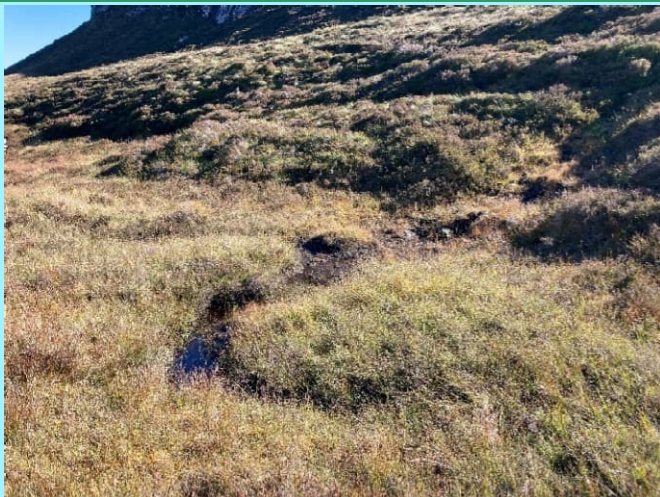
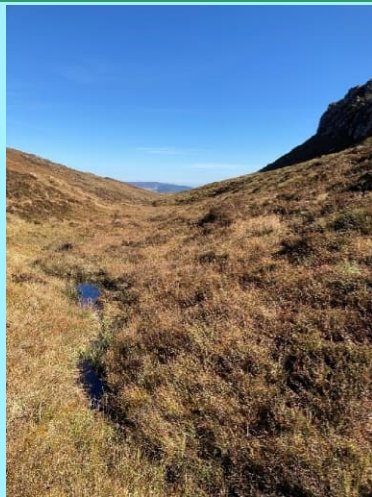
ID, NGR and Crossing Type	Description	Upstream	Downstream
<p>SW11-B Crossing 2</p> <p>NH 45652 23217</p> <p>Type 3 – Bottomless Culvert</p>	<p>Proposed access track watercourse crossing of unnamed tributary of Allt Coire an Ruighe.</p> <p>This is a small shallow watercourse created by hillslope runoff. The channel is poorly defined, with a general lack of coarse bed material or bedrock.</p>

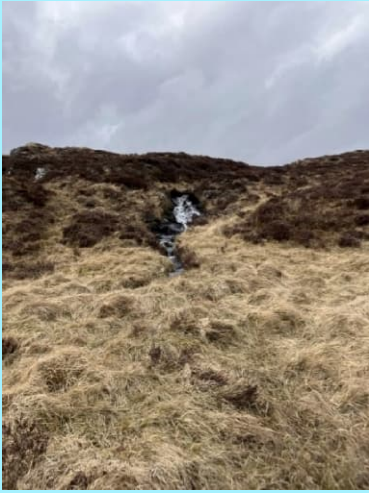
ID, NGR and Crossing Type	Description	Upstream	Downstream
SW5-E Crossing 2 NH 44505 22690 Type 3 – Bottomless Culvert	<p>This un-named tributary to Allt Loch an t-Sionnaich is the outfall from Loch Ruighe an t-Seilich and will flow into the Headpond. An access track is proposed over this watercourse to give access to the Embankments.</p> <p>The channel is small and dominated by cobbles and bedrock with a step pool typology.</p>

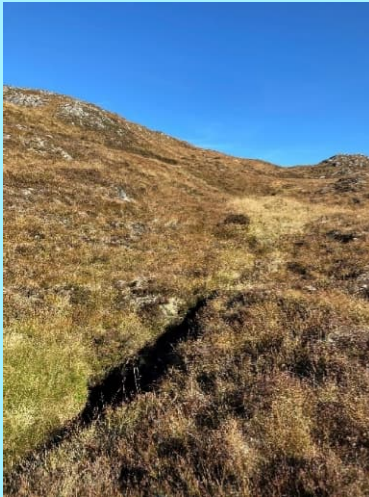
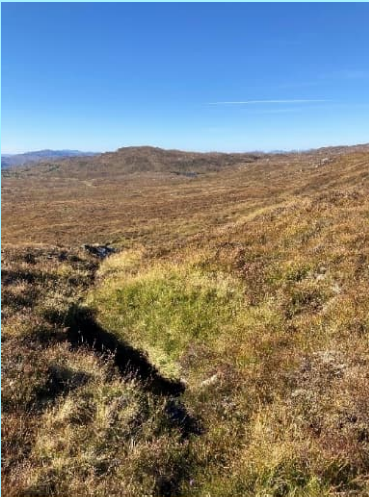
<p>Photograph taken approximately 120 m downstream of crossing location</p>

<p>Photograph taken approximately 35 m downstream of the crossing location.</p>	
SW5-E Crossing 3 NH 44441 22475 Type 3 – Bottomless Culvert	<p>This un-named tributary to Allt Loch an t-Sionnaich is the outfall from Loch Ruighe an t-Seilich and will flow into the Headpond. An access track is proposed over this watercourse to give access to the Embankments.</p> <p>The channel is small and dominated by cobbles and bedrock with a step pool typology.</p>

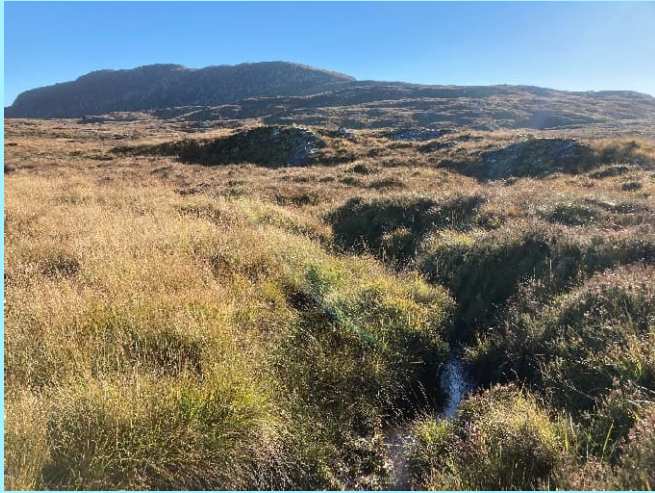
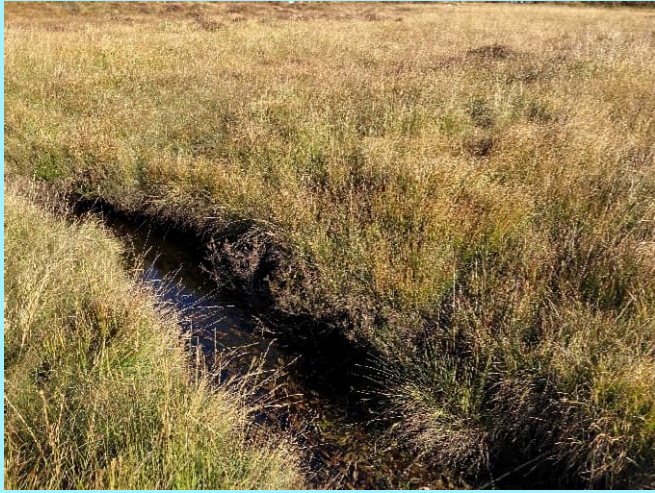
<p><i>Photograph taken approximately 350 m downstream of crossing location</i></p>

ID, NGR and Crossing Type	Description	Upstream	Downstream
SW5-B Crossing 1 NH 43749 21993 Type 3 – Bottomless Culvert	<p>Proposed crossing of an unnamed tributary to Allt Loch an t-Sionnaich for access to the Embankments.</p> <p>The channel was observed approximately 350 m downstream of the crossing location and was seen to gently meander around areas of hard bedrock. The channel was deep and incised into the soft ground with no visible gravels.</p>

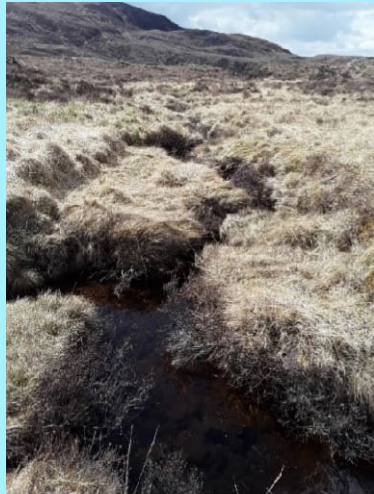
<p><i>Photograph taken approximately 400 m upstream of crossing location.</i></p>	<p>No Associated Photographs</p>

<p><i>Photograph taken approximately 350 m downstream of crossing location</i></p>
SW13 Crossing 1 NH 44627 23729 Type 3 – Bottomless Culvert	<p>Proposed crossing of Allt Glas Mòr for access to the Embankments.</p> <p>The channel is incised and flowing through peat dominated moorland. The planform is sinuous but appears to have been stable over time (i.e. not actively meandering). There is a general lack of coarse sediment.</p> <p>The location of the actual crossing was not visited. Aerial imagery depicts a well-defined channel at the crossing location, of similar size and form to the site photographed.</p>

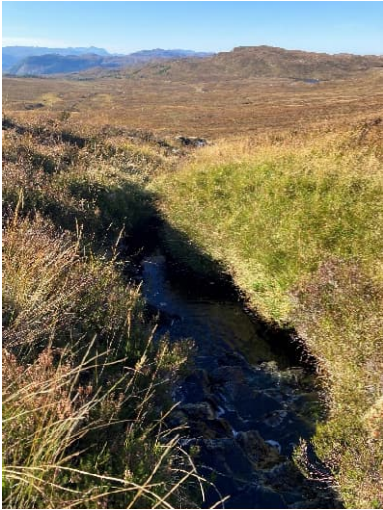
Breach of 50 m Buffer	Water feature	Works Description	Photograph
NH 48111 21786	Loch Ness	Lower Control Works	No Associated Photographs
NH 44374 22429	SW15	The Main Dam and Headpond will directly cut off by the Main Dam.

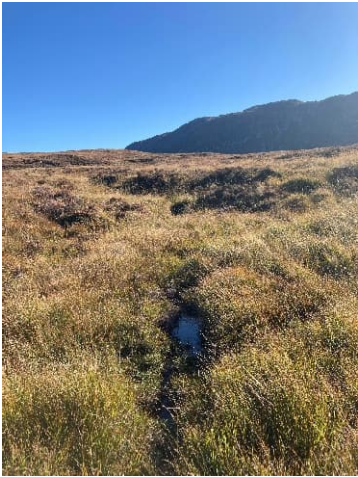
Breach of 50 m Buffer	Water feature	Works Description	Photograph
NH44453 22292	Tributary to SW15	Will be lost to the Proposed Development

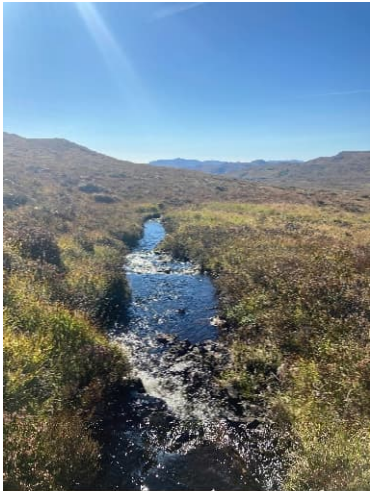
NH44633 21965	SW5	The upper reaches of this watercourses between Loch nam Breac Dearga and where the Main Dam will be located will be lost to the Proposed Development.

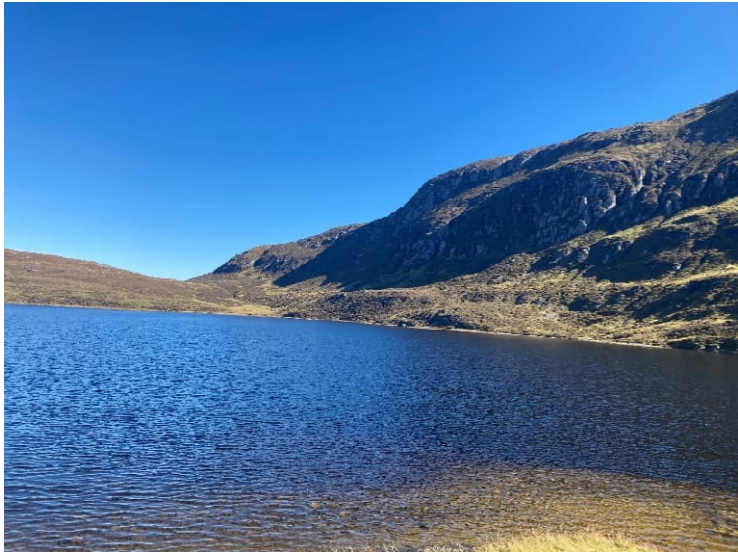
Breach of 50 m Buffer	Water feature	Works Description	Photograph
NH 45130 22288	Loch nam Breac Dearga (SW8)	Loch Nam Breac Dearga will be completely lost to the Proposed Development.

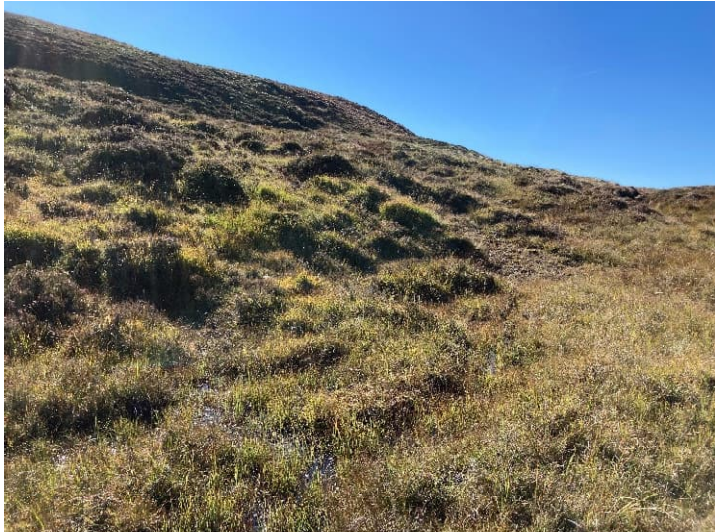
20 m from Saddle Dam 2	Allt Coire an Ruighe (SW11)	Saddle Dam 2 will be built upgradient from SW11.

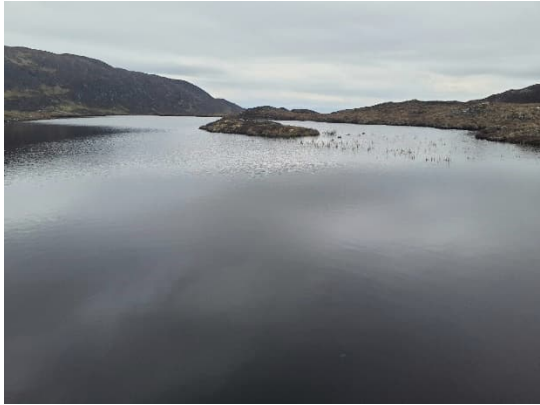
Breach of 50 m Buffer	Water feature	Works Description	Photograph
SW16 lies approx. 35 m east of Saddle Dam 1	SW16	Saddle Dam 1
